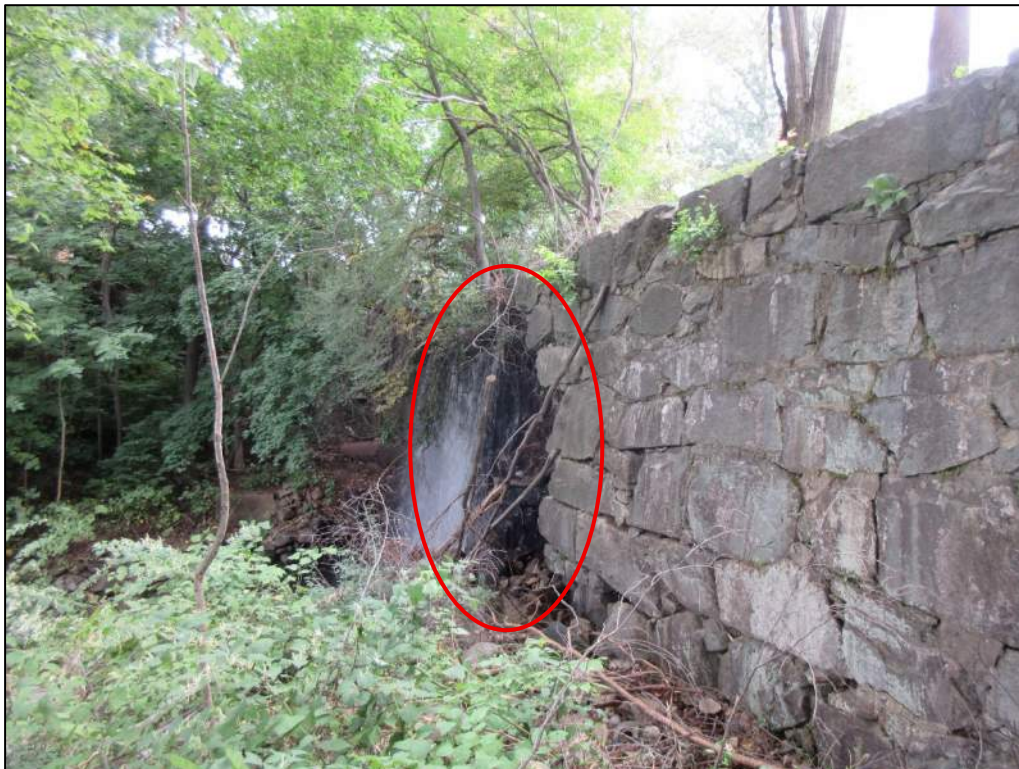
**Photo 1 – Overview of downstream face of dam from south end; note partially failed section circled in red**

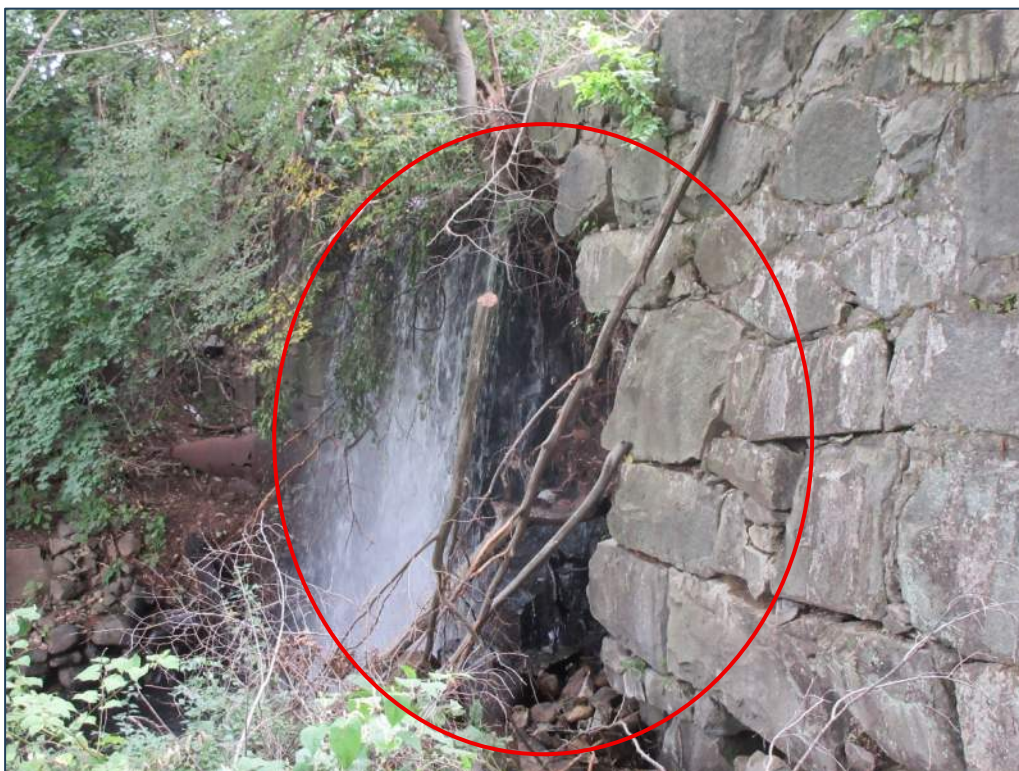
**Photo 2 – Partially failed section of dam adjacent to spillway**

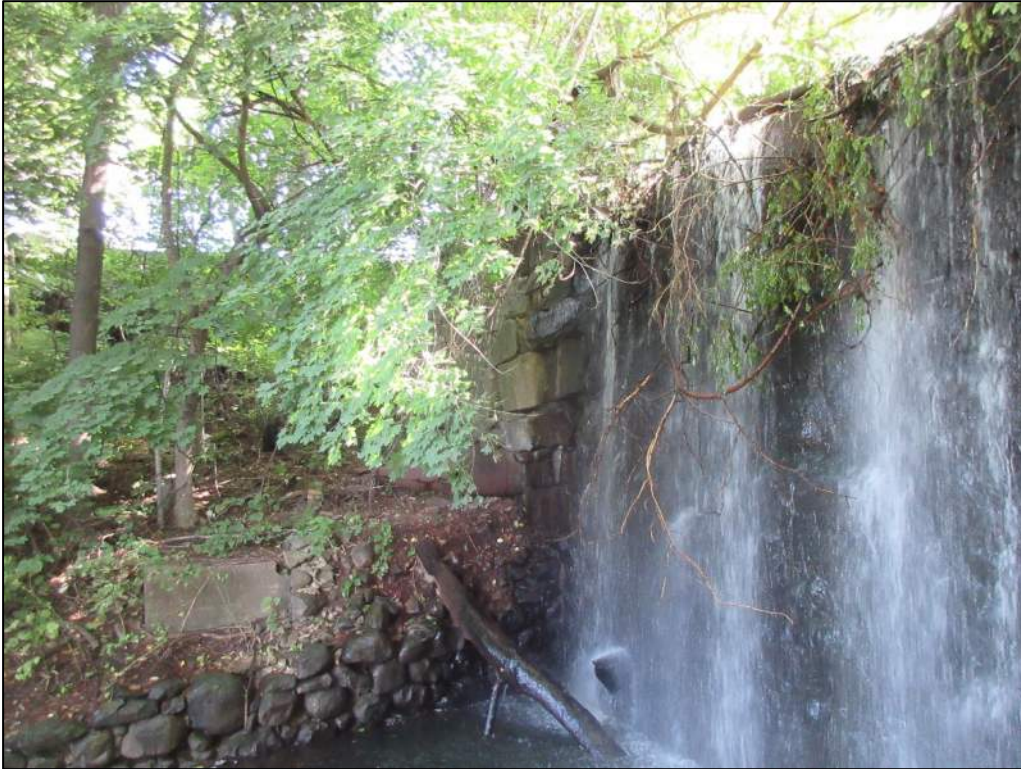
**Photo 3 – Overview of downstream face of spillway and north side of dam**

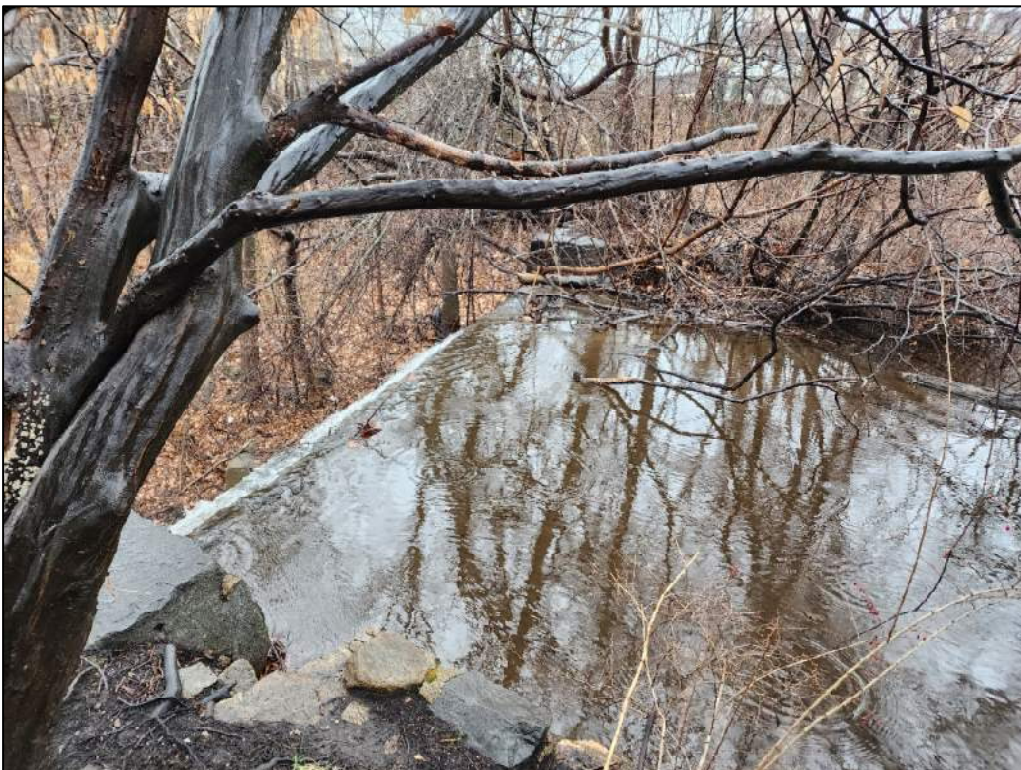
**Photo 4 – Overview of spillway weir; note sediment level is just below the weir**

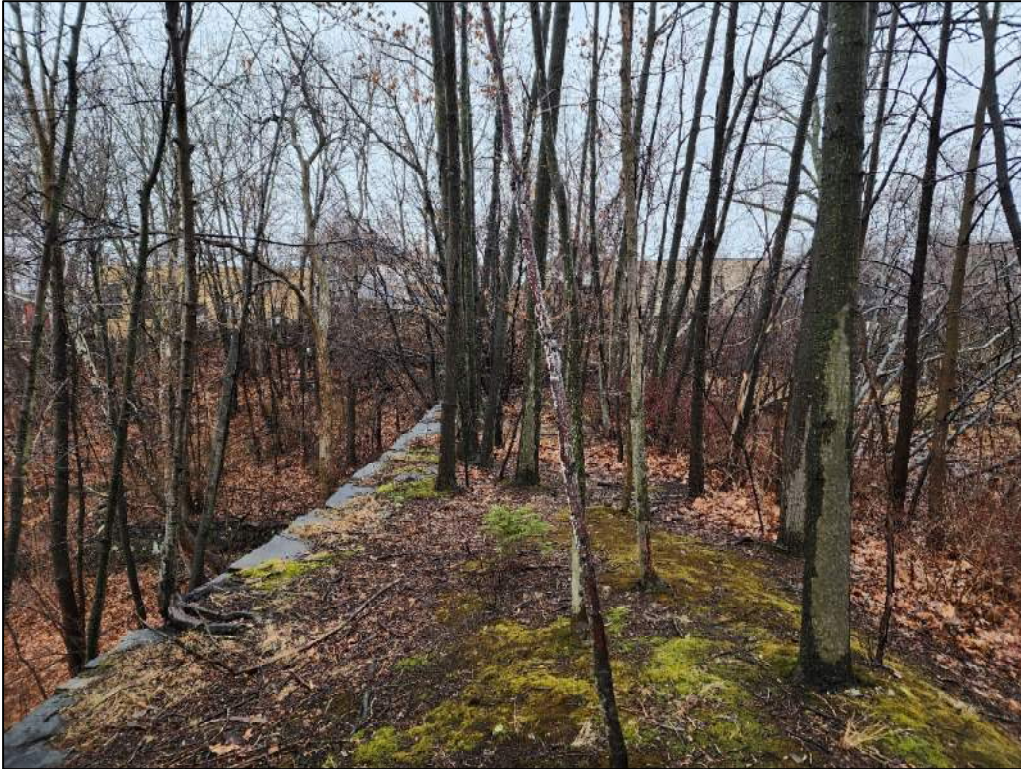
**Photo 5 – Overview of dam crest from south end**

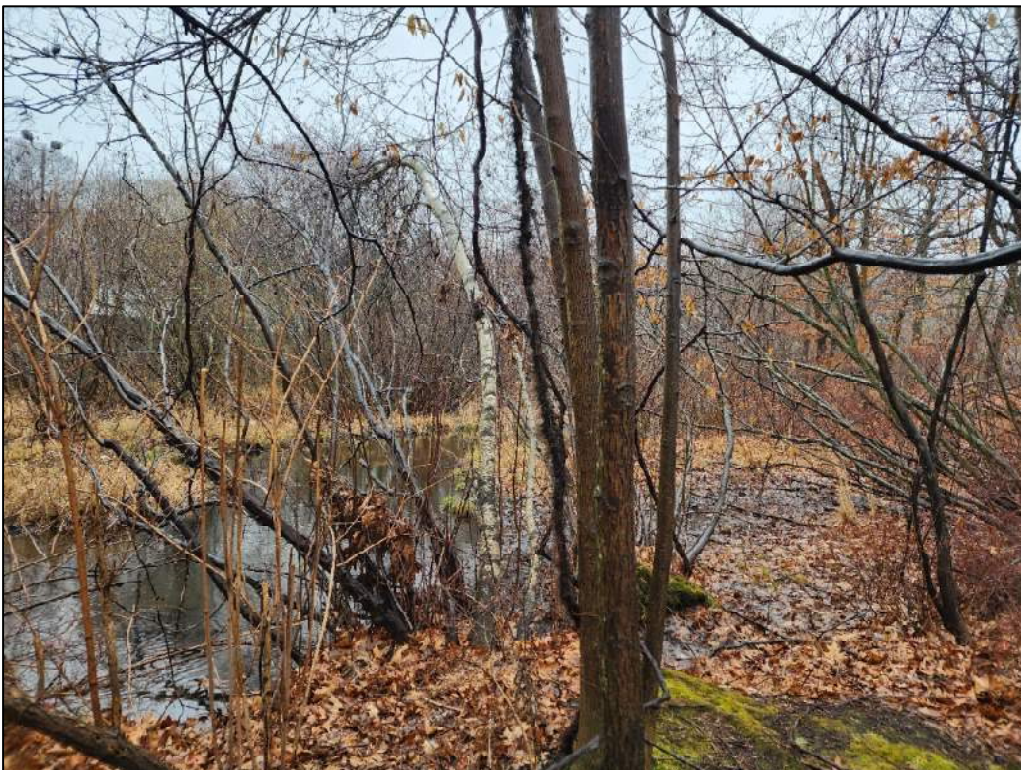
**Photo 6 – Overview of small impoundment area**
