Battalion Chief Examination Reading List

A Career Lieutenant and a Career Fire Fighter Found Unresponsive at a Residential Structure Fire – Connecticut

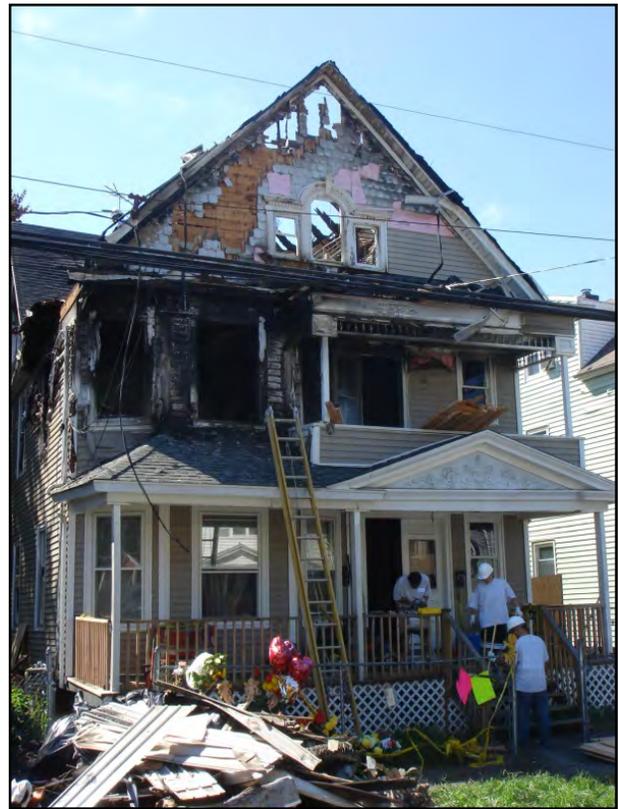
Built in the early 1900s, the two-and-half-story house (see Photo 1) was purchased approximately 4 years prior to the incident as a multifamily rental occupancy. One family lived in the 1st floor apartment (approx. 1,300 sq. ft.); a second family lived in the 2nd floor apartment (approx. 1,300 sq. ft.) (See Diagram 2), and the owner occupied the finished half-story or attic space (approx. 700 sq. ft.) (See Diagram 3). The house also contained an unfinished basement (approx. 1,300 sq. ft.). The common front entrance contained access to the 1st floor apartment and a private stairwell, located at the A/D corner of the house, which provided access to the 2nd floor apartment. The house also had a single rear-entry door that provided access to a stairwell that led up to the owner's apartment and had landings to access all the apartments from the rear. According to the owner of the house, smoke detectors were installed within the house about a year prior to the incident. These smoke detectors were installed in every bedroom, in each hallway, and in the stairwells. The house did not have an installed sprinkler system and had been inspected in accordance with Department of Housing and Urban Development Section 8^a guidelines, according to the homeowner. The house was Type V wood frame construction, but, during the initial stages of the fire, was presumed by arriving fire fighters to be balloon-framed due to the era when it was constructed. State fire investigators were able to confirm Type V construction after closer inspection.

Photo 1. A-side of house during cleanup operations.
(NIOSH photo.)

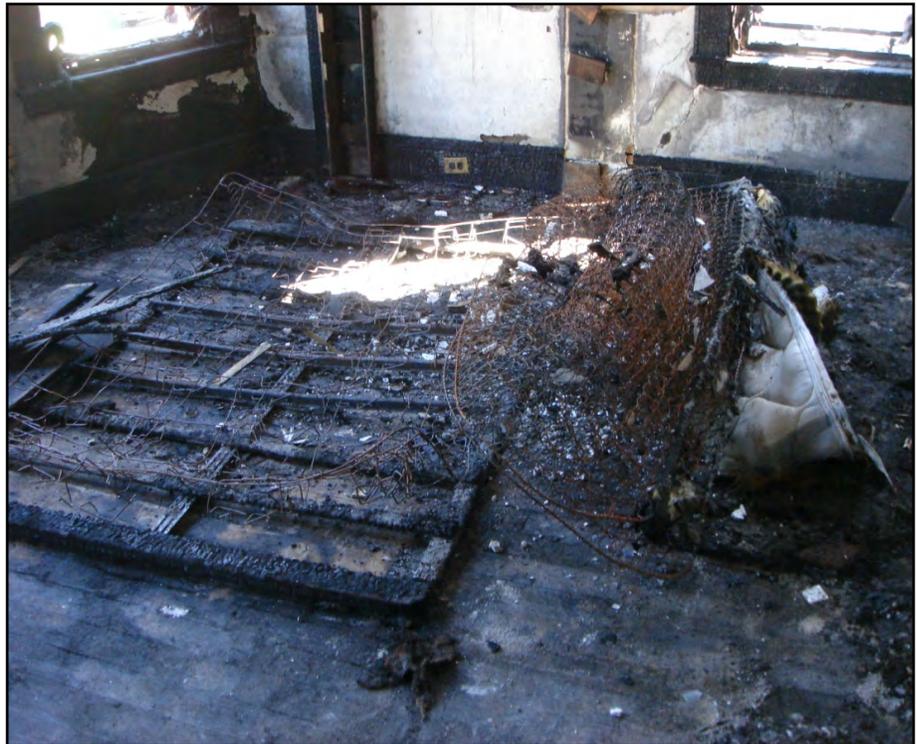
The room and contents fire was determined to have originated in a bedroom on the 2nd floor, A/B corner; it was quickly knocked down by E3 (see Photo 2). It is believed that the fire got into the eaves when it was lapping out the A/B corner windows, and then spread within the large void spaces in the ceiling and walls of the 3rd floor. The fire was situated toward the A/B corner of the 3rd floor, but the open void areas allowed smoke to accumulate within the ceilings and walls before they were opened.

**Photo 2. Remnants of a mattress and box springs within the room of origin on the 2nd floor.
(NIOSH photo.)**

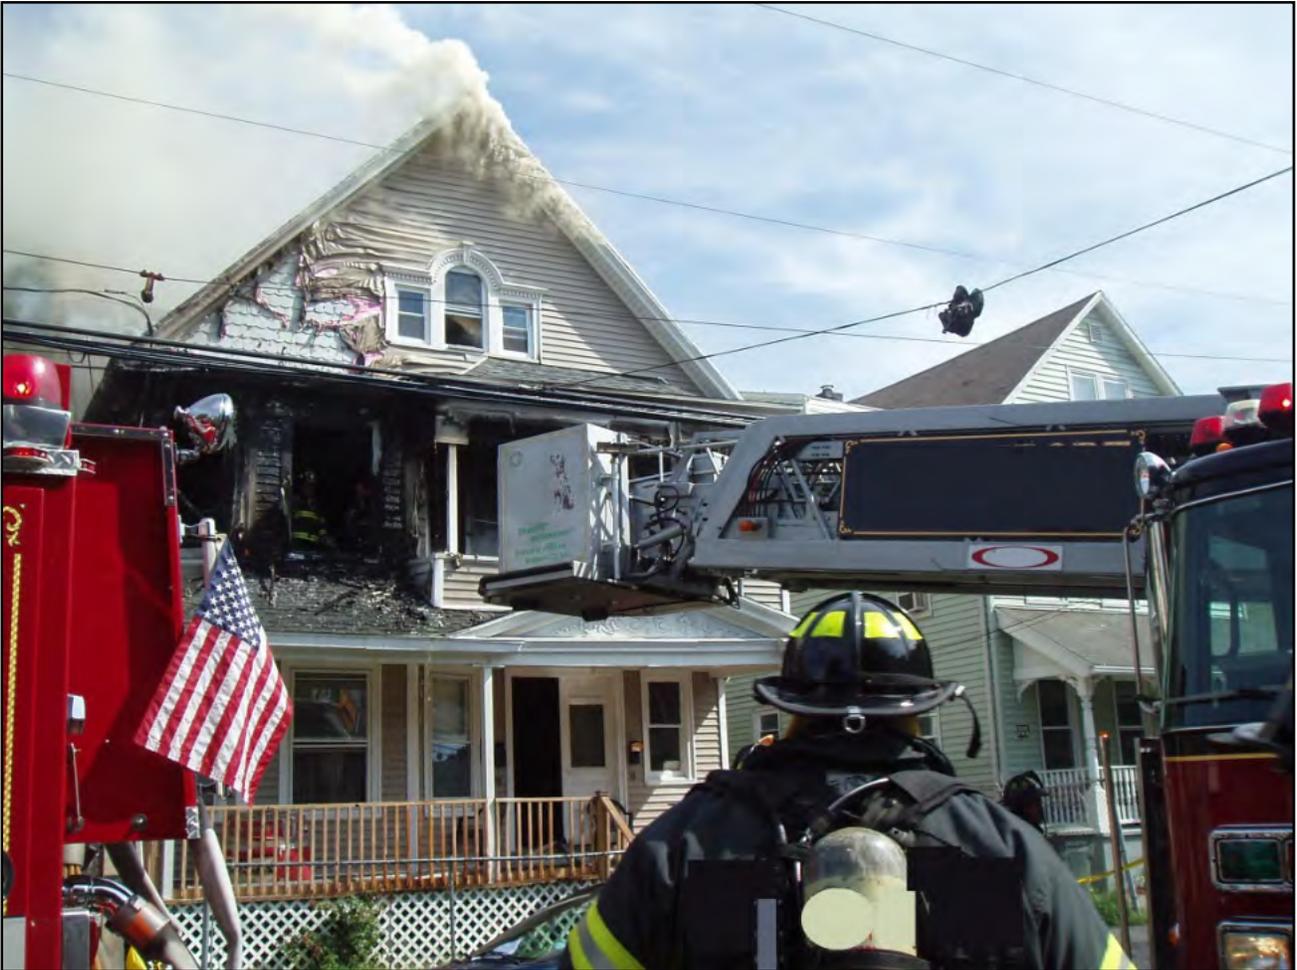
Photo 3. Initial conditions observed when the BC arrived on scene at approximately 1551 hours.
Note: Fire was under control on the 2nd floor and fire fighters were checking for extension. White-to-gray smoke can be seen flowing in the direction of right to left from the gables. The A-side window on the 3rd floor had been opened for ventilation (unsure at what stage of the fire or by whom).
(Photo courtesy of fire department.)

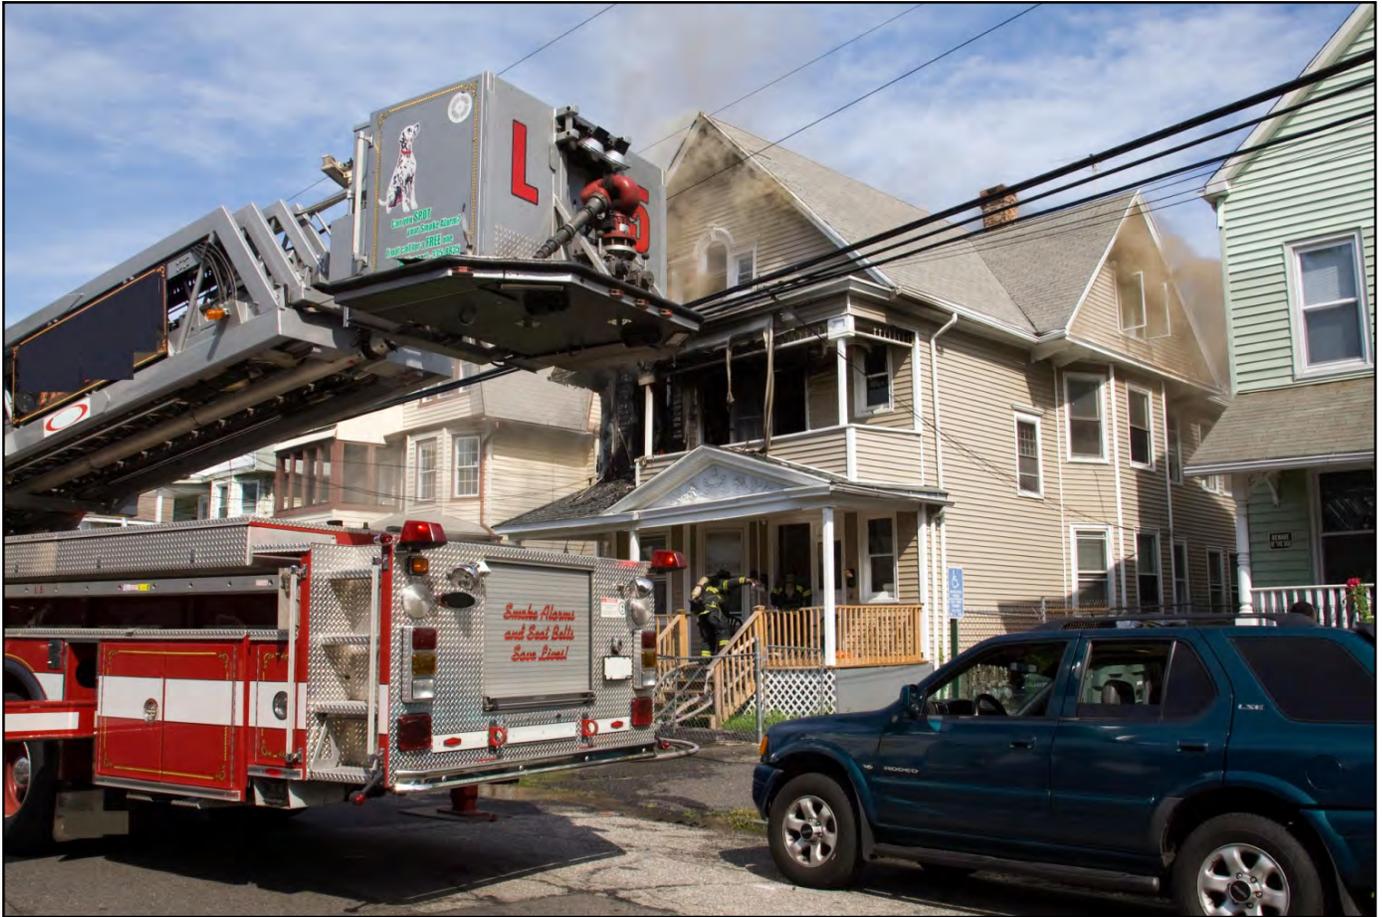
Photo 4. Conditions observed at 1608 hours by an off-duty fire fighter. *Note: Smoke had changed to gray and brown in color and was emitting from the eaves and A- and D-side windows which were manually opened by personnel working on the 3rd floor. A hoseline was being stretched to the 3rd floor.*

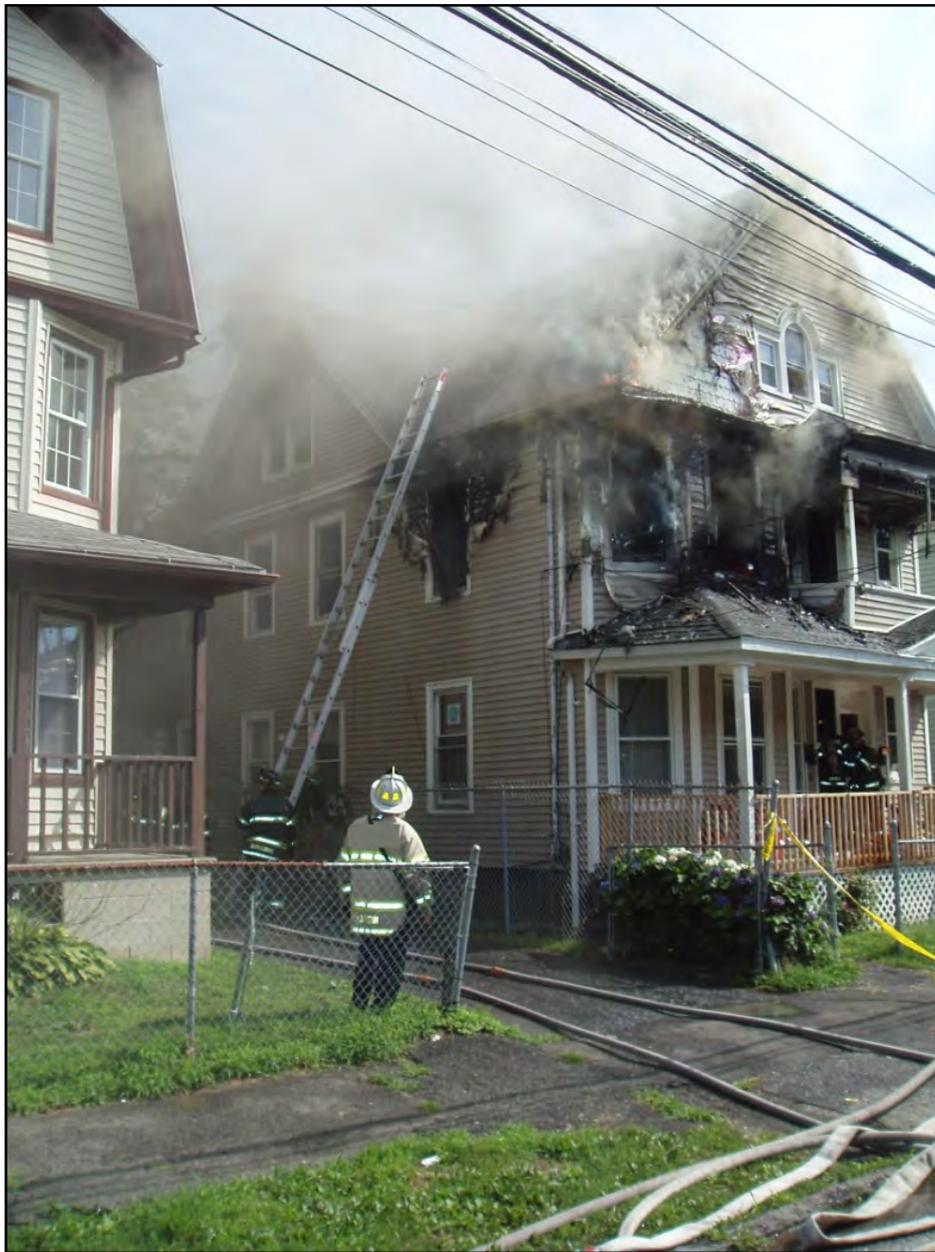
Photo 5. Conditions at approximately 1609 hours. *Note: L5 personnel were preparing to ascend the ladder placed on the B-side of the house. The IC (white helmet) is observing the scene. Smoke seen coming from the 3rd floor B-side double window and pushing from the eaves. At this time, ceiling and walls were likely being opened on the 3rd floor, and water would have been available.*
(Photo courtesy of fire department.)

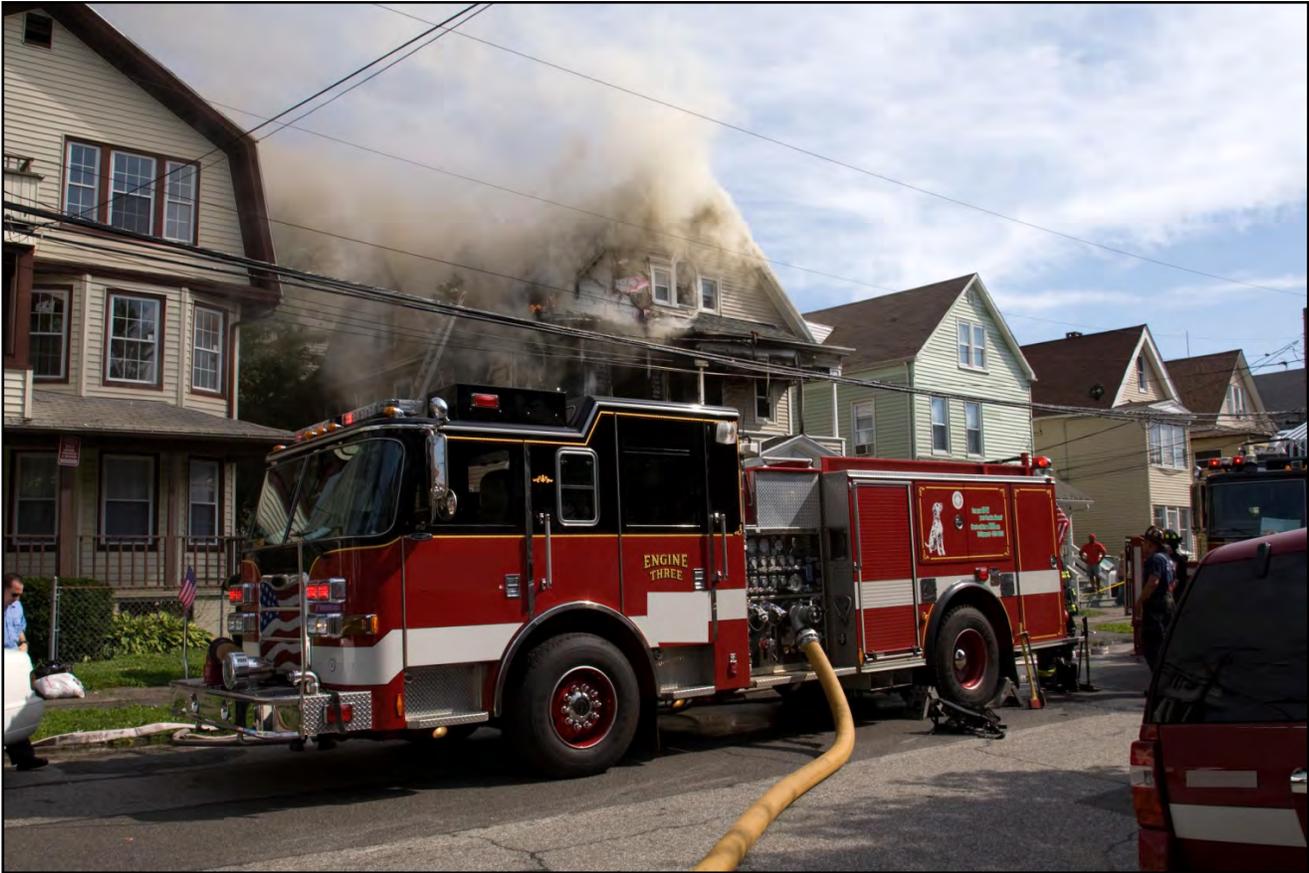
Photo 6. Conditions at approximately 1611 hours. *Note: L5 personnel were ascending the roof from the ground ladder on the B-side. Smoke color was still gray to brown in color and was becoming denser. Personnel were still working on the 3rd floor. Wind direction was right to left.*
(Photo courtesy of Keith Muratori.)

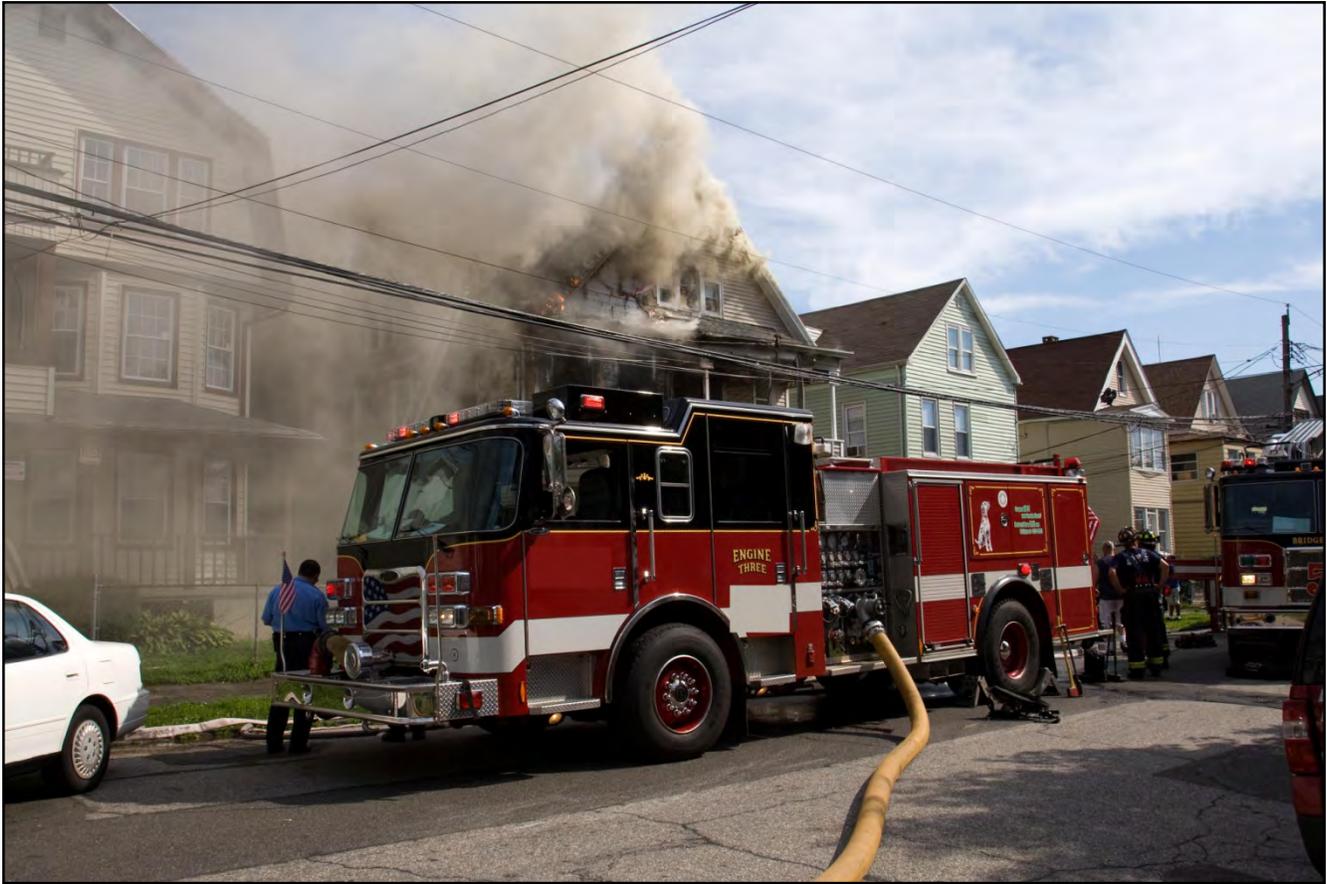
Photo 7. Conditions at approximately 1613 hours. *Note: L5 personnel were on the peak of the roof and having difficulty starting the roof saw. Smoke was denser than before and pushing from the roof and eaves. The fire fighters were unable to vent the roof. NIOSH investigators believe that Victim #1 transmitted his Mayday about this time.*
(Photo courtesy of Keith Muratori.)

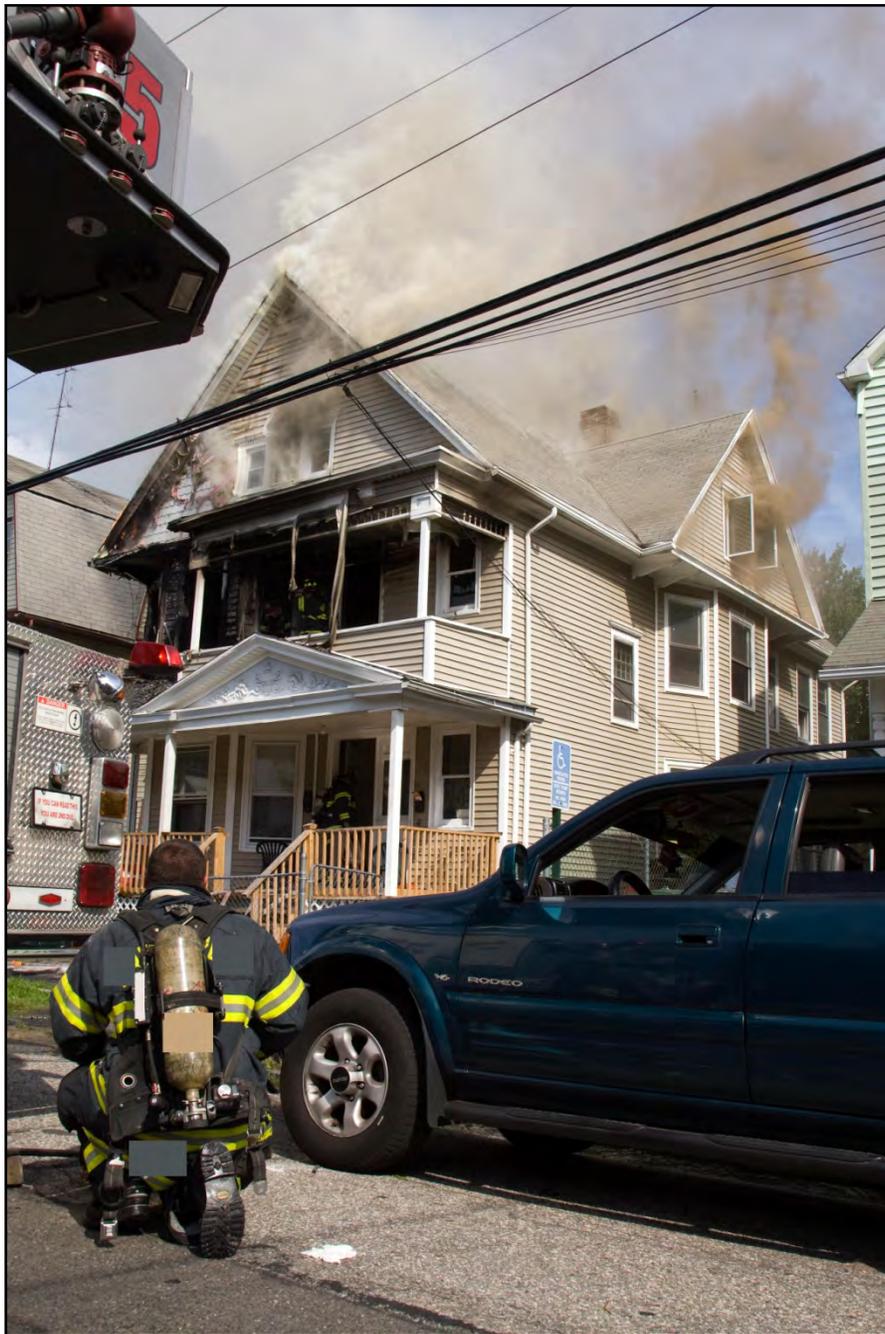
Photo 8. Conditions at approximately 1616 hours. *Note: View from the A/D corner, scene conditions very close to when FF2 discovered FF1 pulling Victim #1 off the 3rd floor stairs. White and gray smoke can be seen flowing from the A-side window and eaves while brown smoke flowed from the D-side window.*

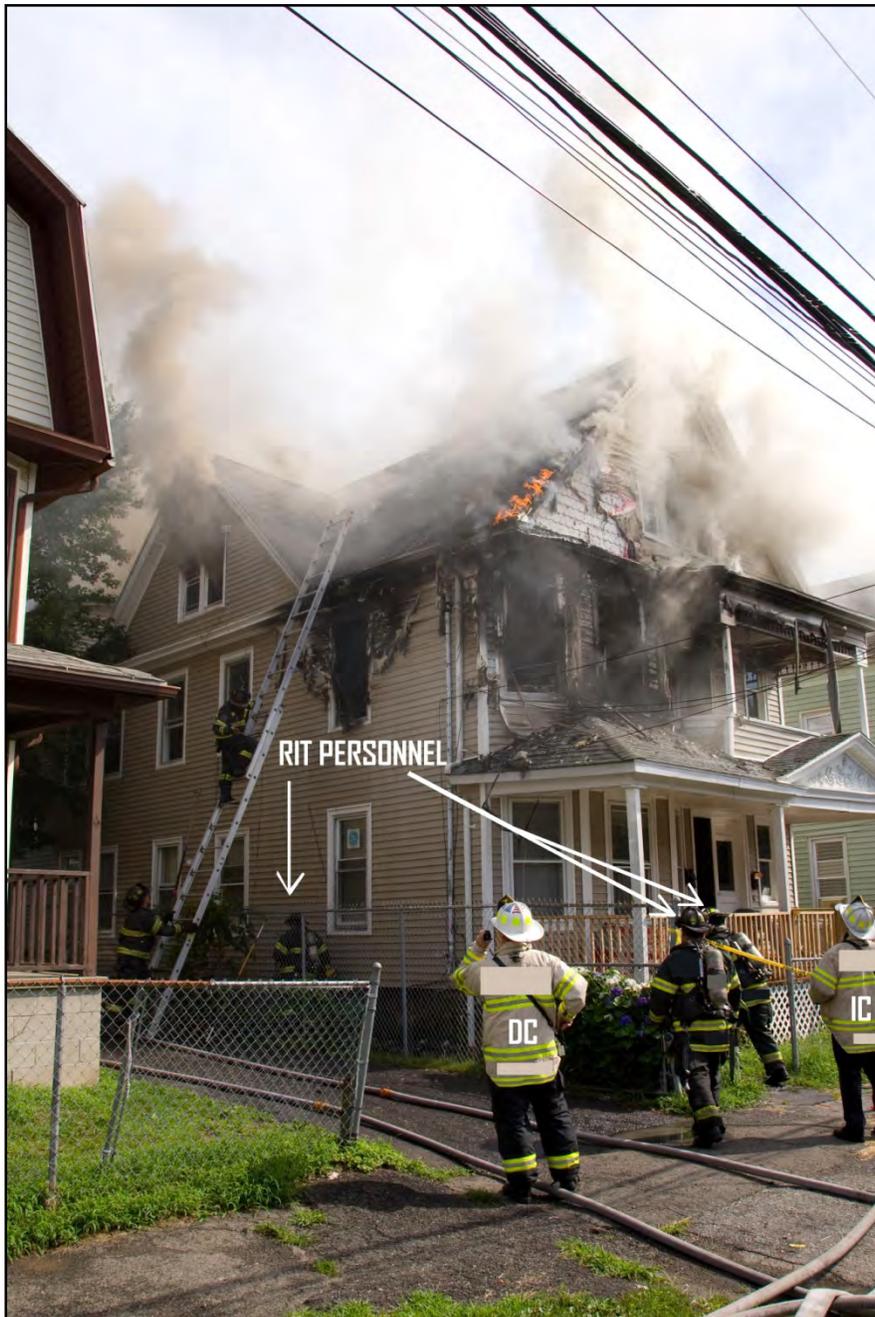
Photo 9. Mayday for Victim #1, called by FF2. Note: RIT personnel from E12 are seen heading to the rear of the house. L5 personnel were descending the roof via the B-side ground ladder. Fire is seen burning along the roof line above the A/B corner. Gray, dense smoke was flowing from the 3rd floor B-side double window and A-side window.
(Photo courtesy of Keith Muratori.)

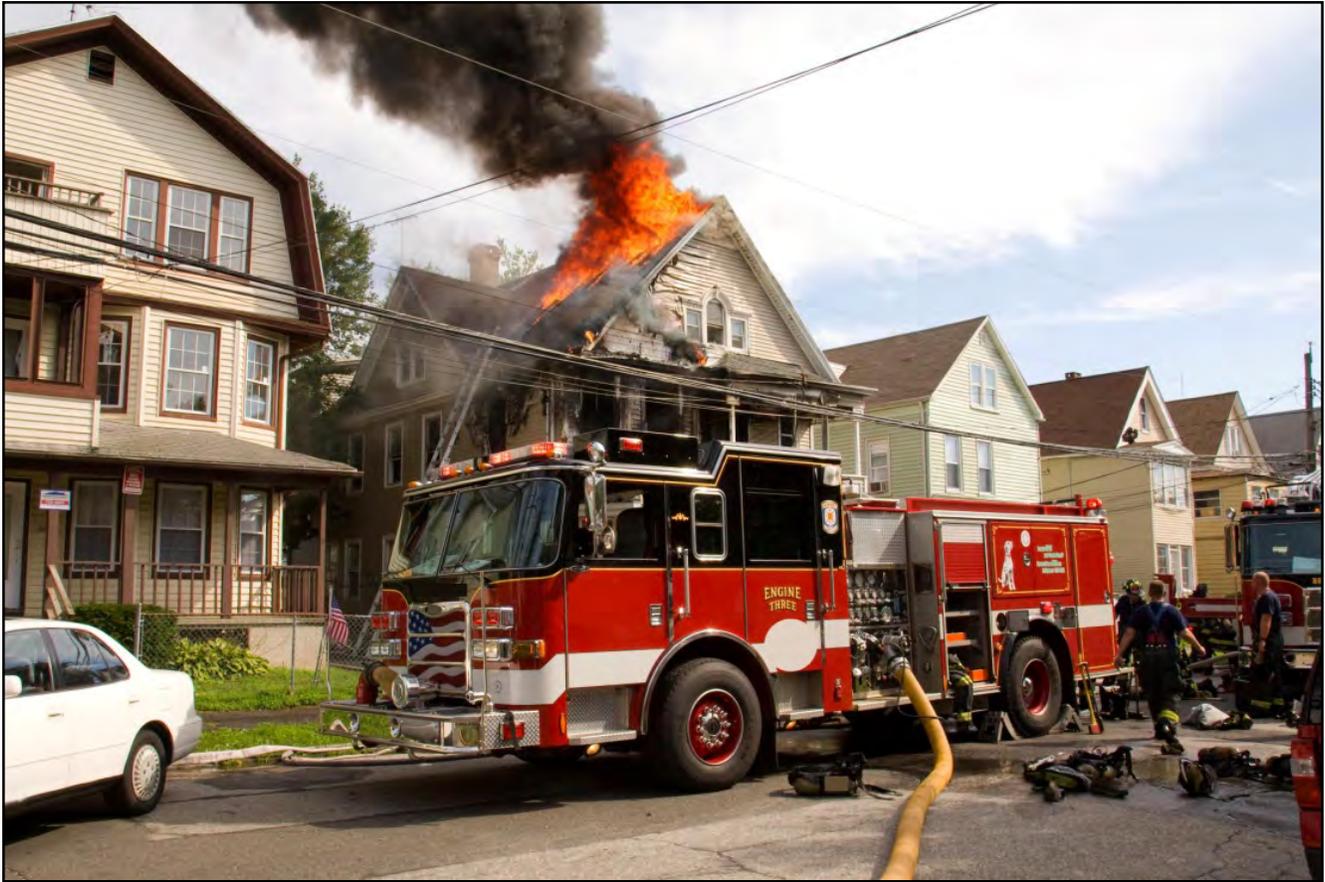
Photo 10. Fire vented through the roof. *Note: NIOSH investigators believe this photo shows conditions very close to the time that the Mayday was called for Victim #2 by FF4. Wind was pushing the smoke plume from right to left.*
(Photo courtesy of Keith Muratori.)

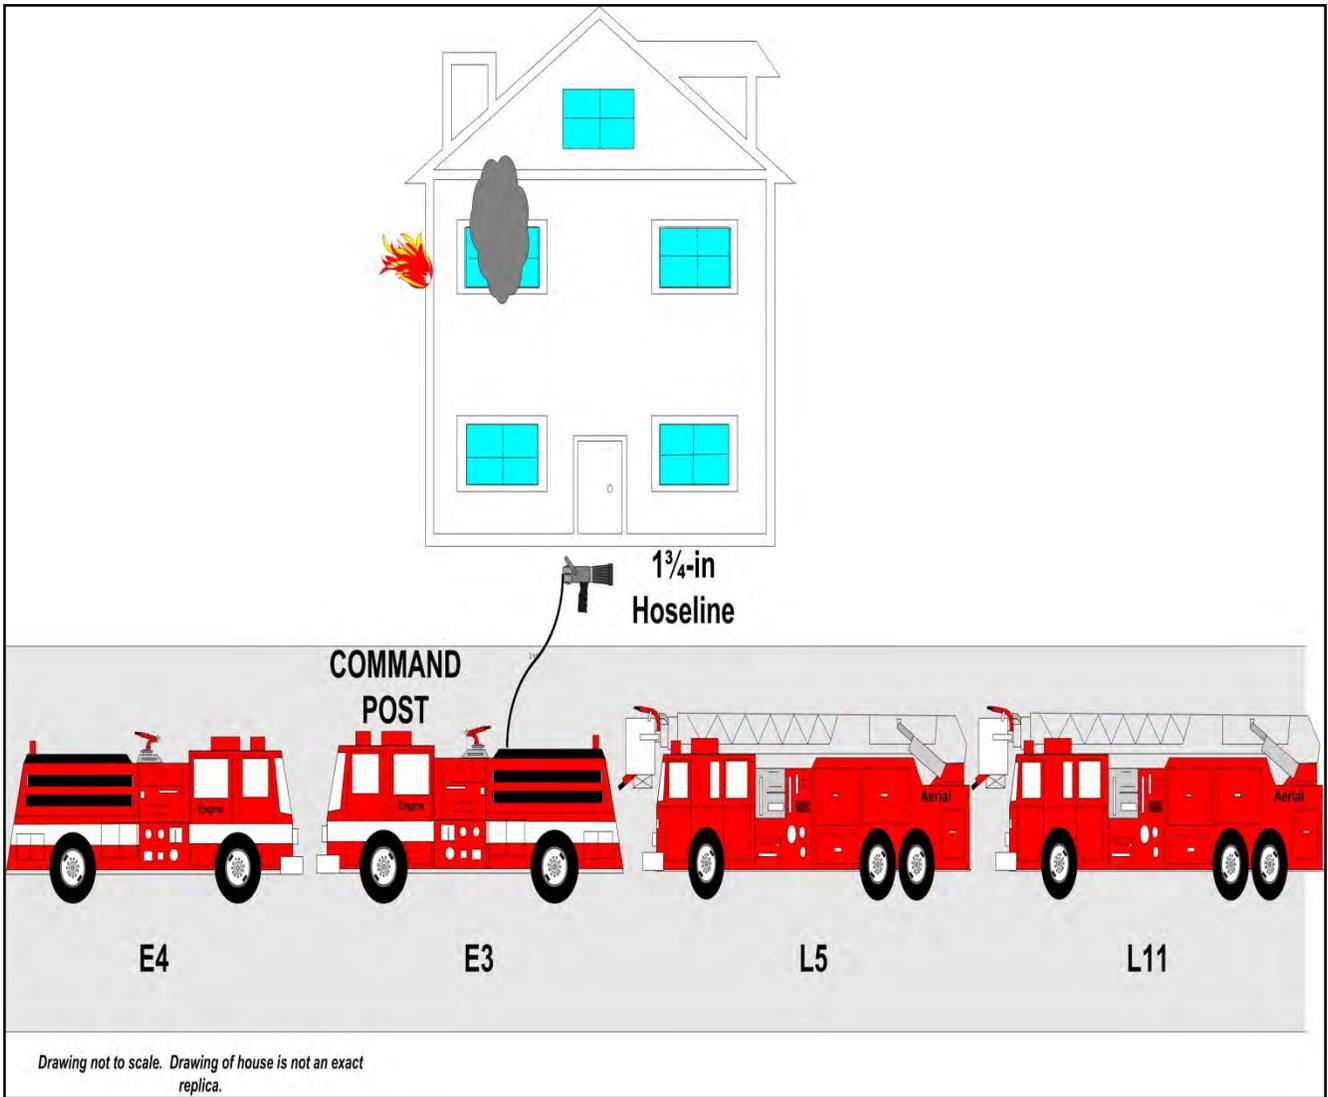
Diagram 1. Initial conditions and fire apparatus on scene. *Note: E4 and L11 arrived on scene after the initial room and contents fire was brought under control.*

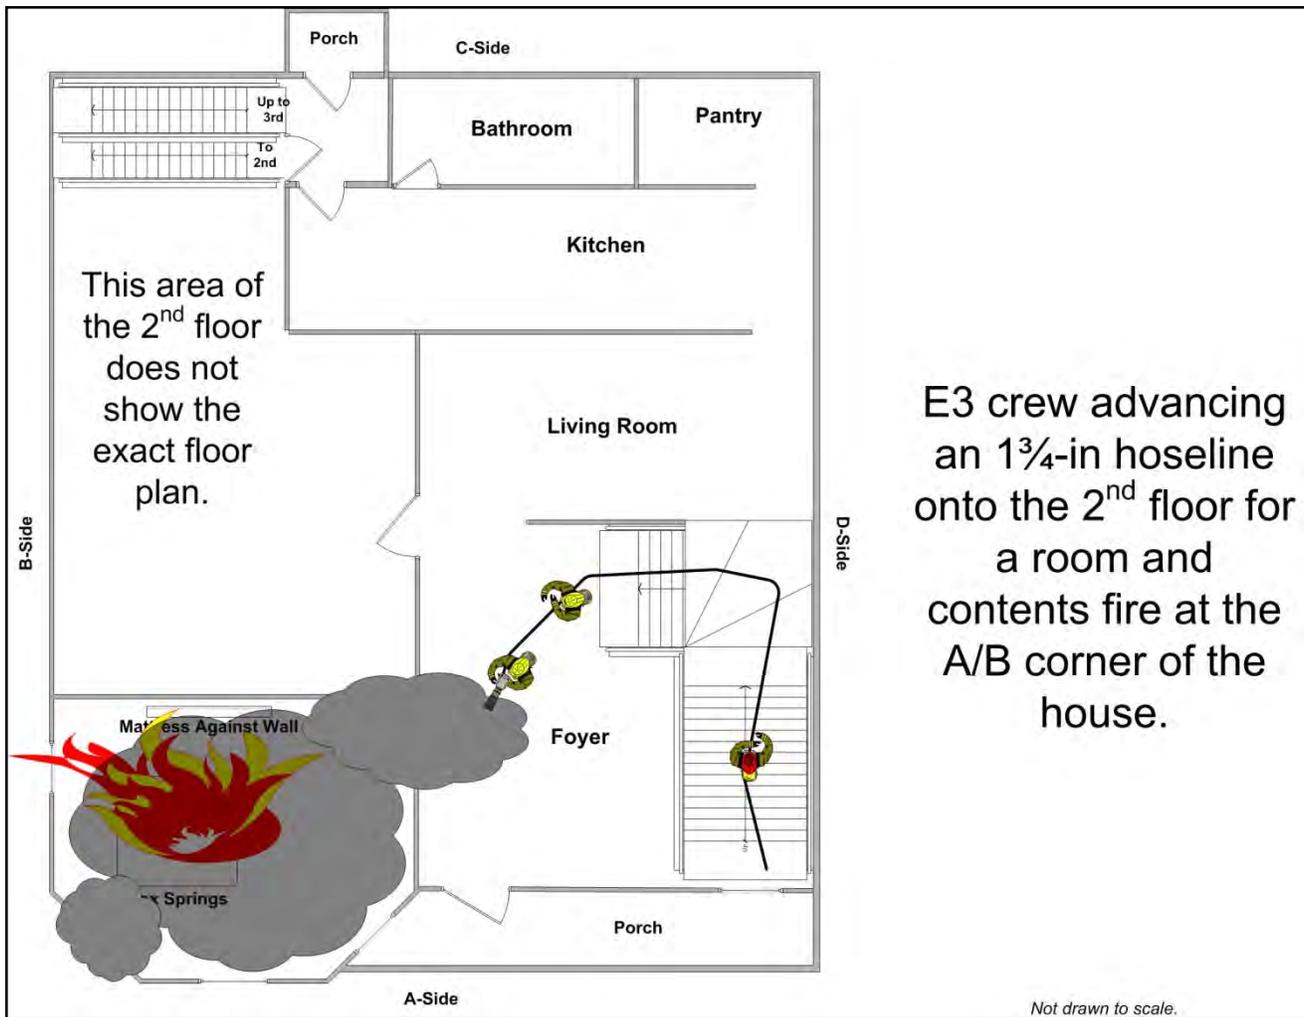
Diagram 4. E3 personnel discovered a room and contents fire on the 2nd floor.

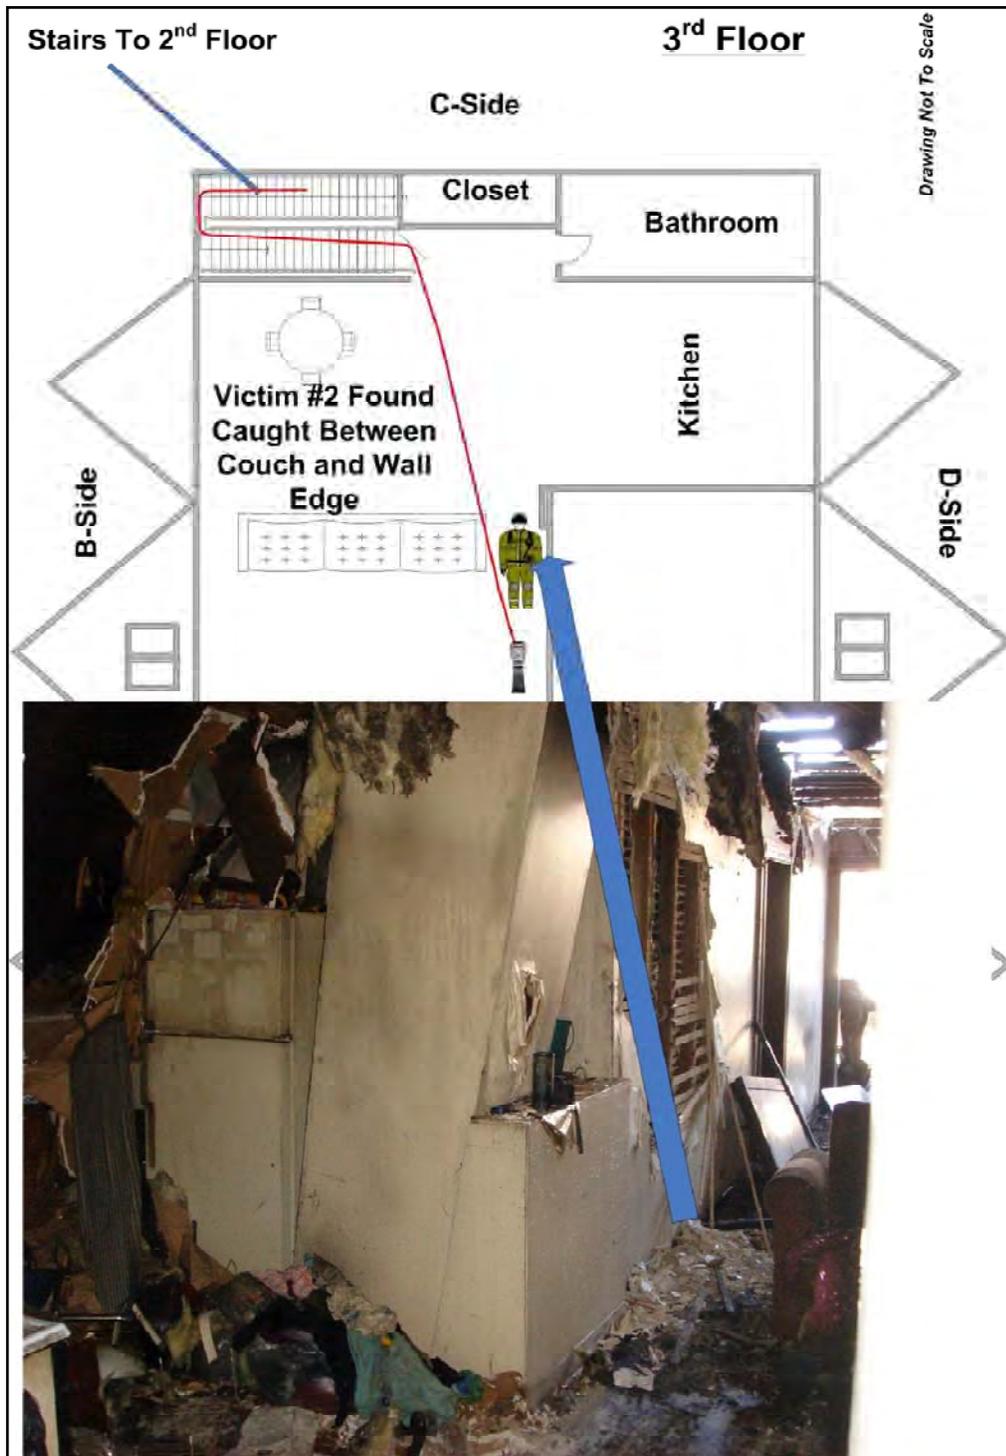
Diagram 5. Shows location of where Victim #2 was found by FF4. *Note: Orientation of the picture differs from the diagram.*

FF4 entered the rear stairwell and went to the 3rd floor (it is unclear if any personnel followed him into the house). He followed a hoseline into the 3rd floor and found Victim #2 apparently lodged between a wall and a piece of furniture (see Diagram 5). Victim #2's PASS device and indicator lights were alarming; he did not have his facepiece on. FF4 stated that he called a Mayday for Victim #2 and then heard evacuation tones over the radio and then air horns from an apparatus. He transmitted a second Mayday because the first one was not acknowledged by dispatch or the IC. Dispatch acknowledged the second Mayday for Victim #2 and set off the evacuation tones (not the Mayday tones), but no further radio traffic from dispatch or the IC confirmed the specifics of the Mayday. The ISO radioed the IC and advised him that they needed additional information on the Mayday that was just called. The RIT and other fire fighters located in the backyard were working on getting to Victim #2 and

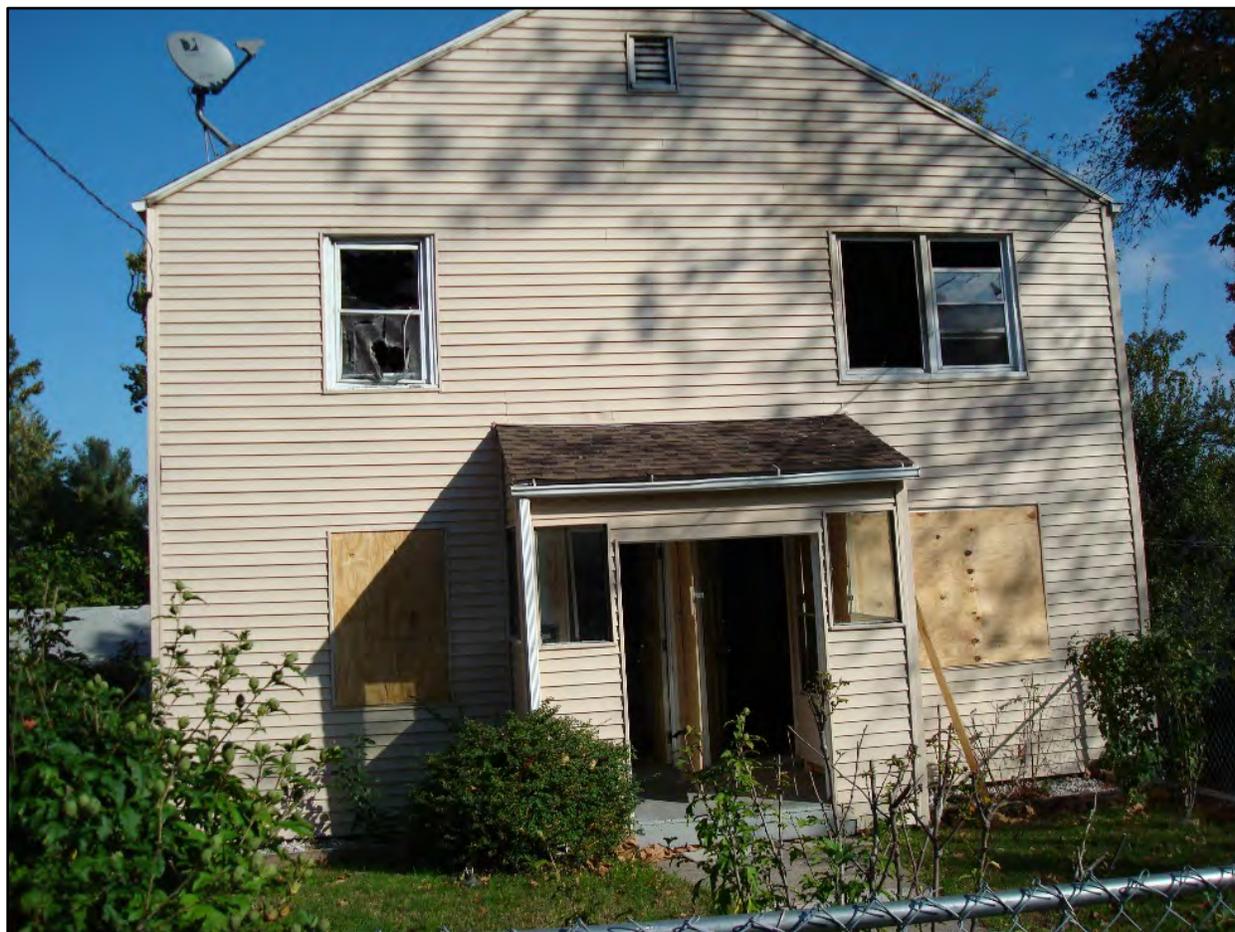
The two-story apartment building was built in 1953 and constructed of a wood frame on a poured concrete basement foundation (see Photos 1–4). The two-story structure consisted of 2,016 square feet of total living space between the two apartments. Each floor consisted of five rooms that included two bedrooms, a living room, a kitchen, and a bathroom. The exterior was covered with vinyl siding, and the pitched roof was covered with asphalt shingles. The structure had a front entrance with two doors: the one on the left opened to an interior stairway to the second floor, and the one on the right to the first-floor apartment. At the top of the stairway was a door with a dead bolt and a second door to the right with a normal entry knob. There was a rear entrance to both floors via a covered porch with stairs to the second floor. The structure had an unoccupied third apartment in the finished basement with an exterior entrance in the rear (Side Charlie) of the structure. The building's utilities were electric and natural gas heating.

Photo 1. Side Alpha—street view of the duplex. Engine 16 and Ladder 4 made entry into the building through the left doorway.
(NIOSH photo.)

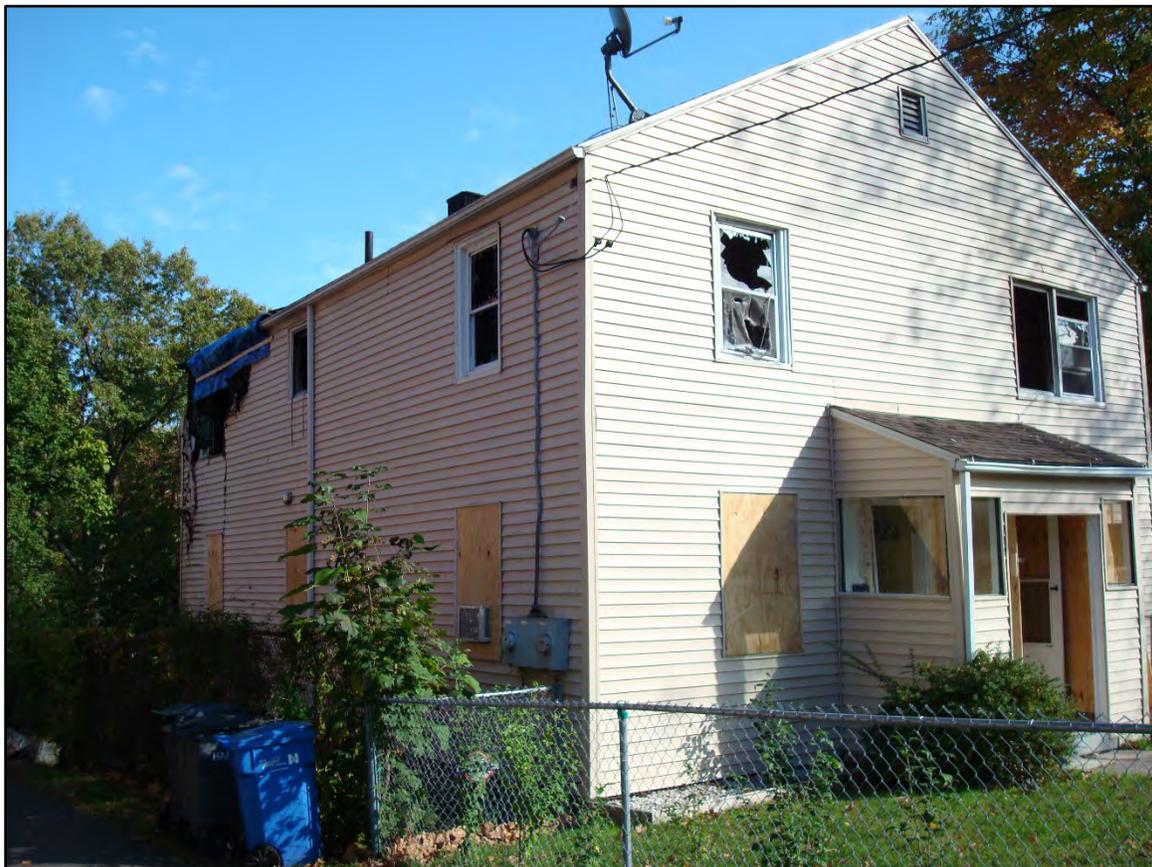
Photo 2. Side Bravo—street view of the duplex. Origin of fire near the Bravo/Charlie corner on the second floor.
(NIOSH photo.)

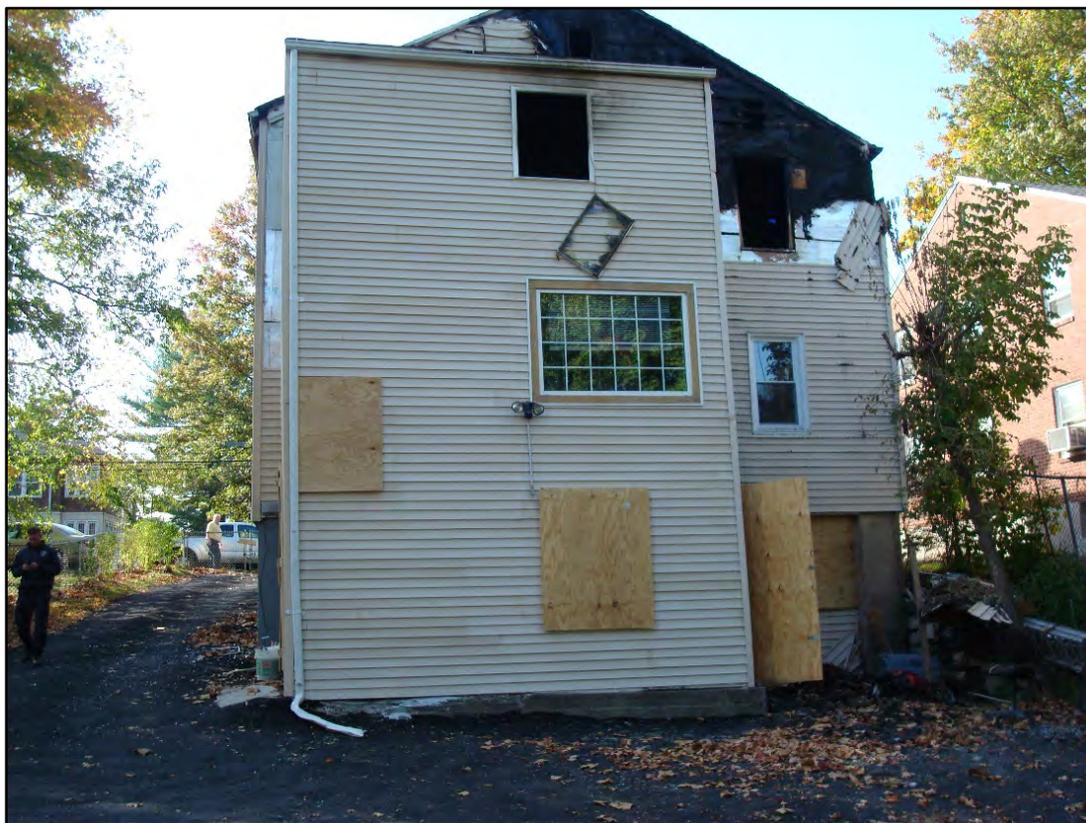
Photo 3. Side Charlie of the structure. An unoccupied apartment was in the basement. The entrance to the basement apartment is on the Bravo/Charlie corner.

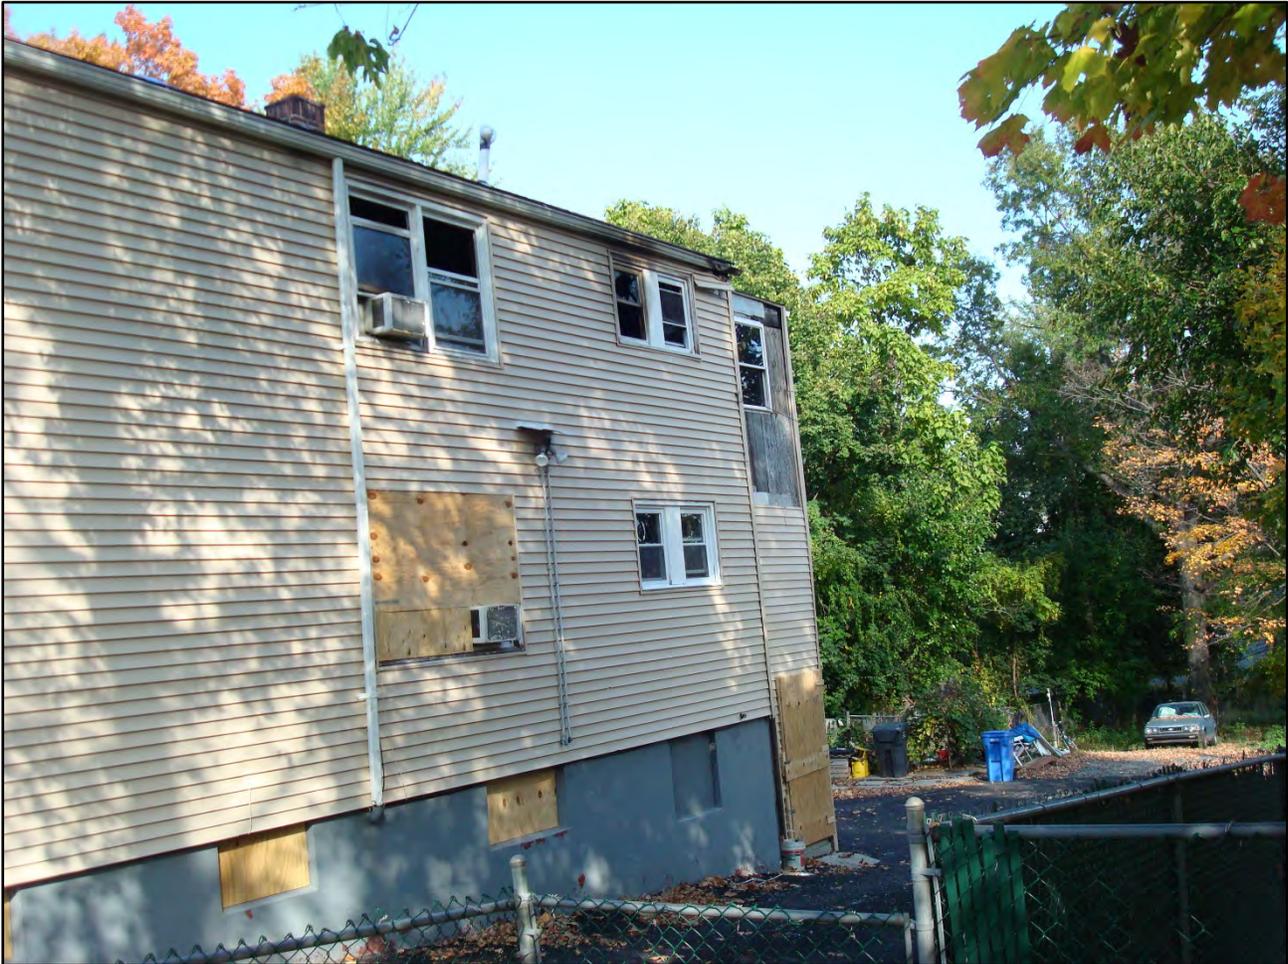
Photo 4. Side Delta of the structure. A rear entrance leads to the first- and second-floor apartments on the Delta/Charlie corner
(NIOSH photo.)

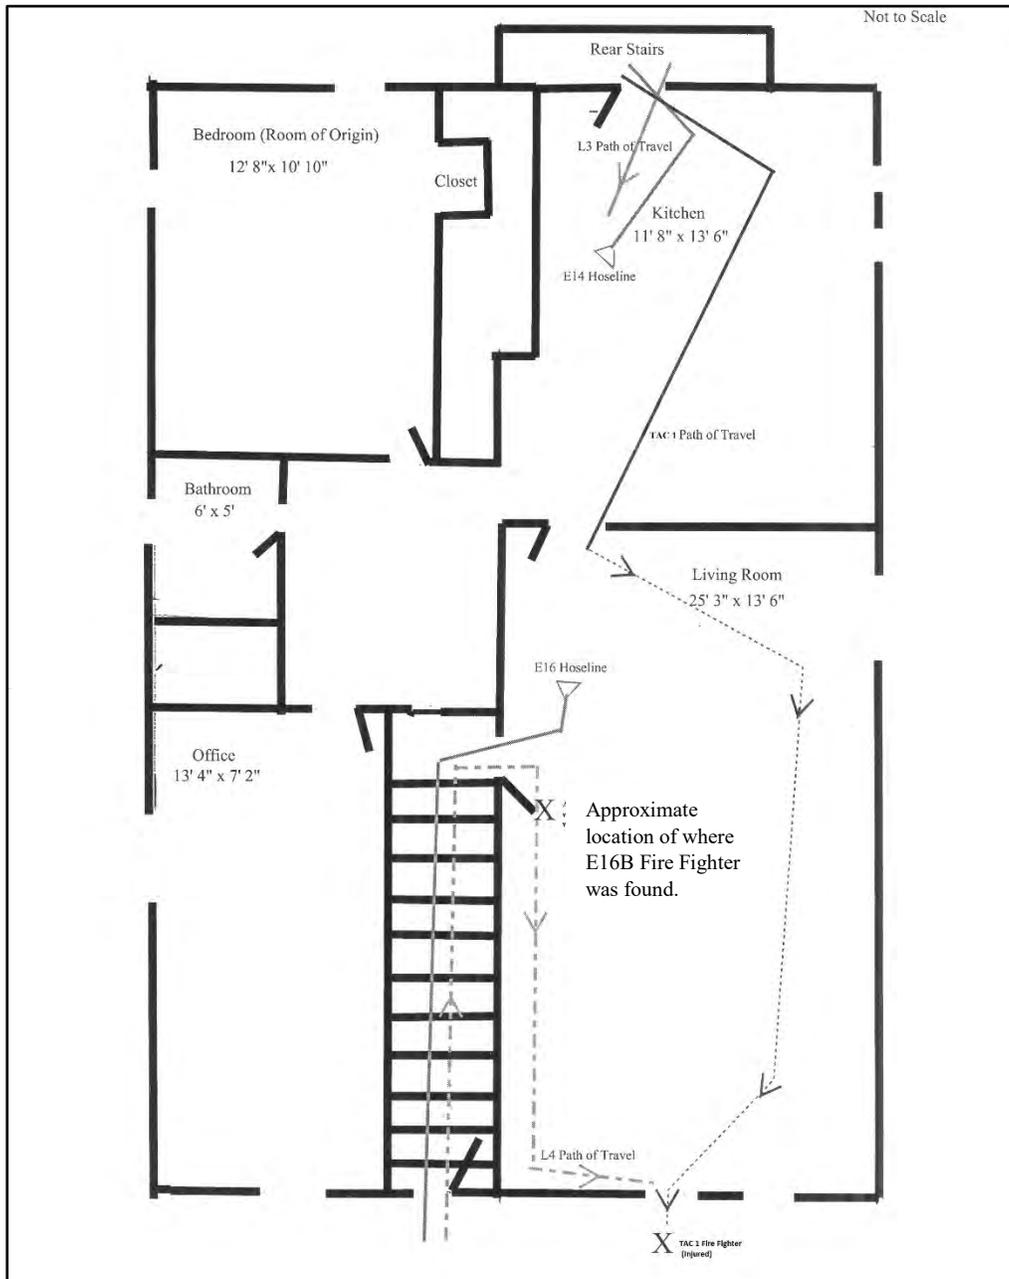
Diagram. Floor plan of second floor, path of attack crews, and location of fire fighters found.
(Diagram courtesy of the fire department.)
