## Assessment of City-Owned Properties

# **Assessment of City-Owned Properties East Main Street Parcel**

**Waterbury, Connecticut  
July, 2015**

MILONE & MACBROOM, INC.  
99 Realty Drive  
Cheshire, Connecticut 06410  
(203)-271-1773  
[www.miloneandmacbroom.com](http://www.miloneandmacbroom.com)

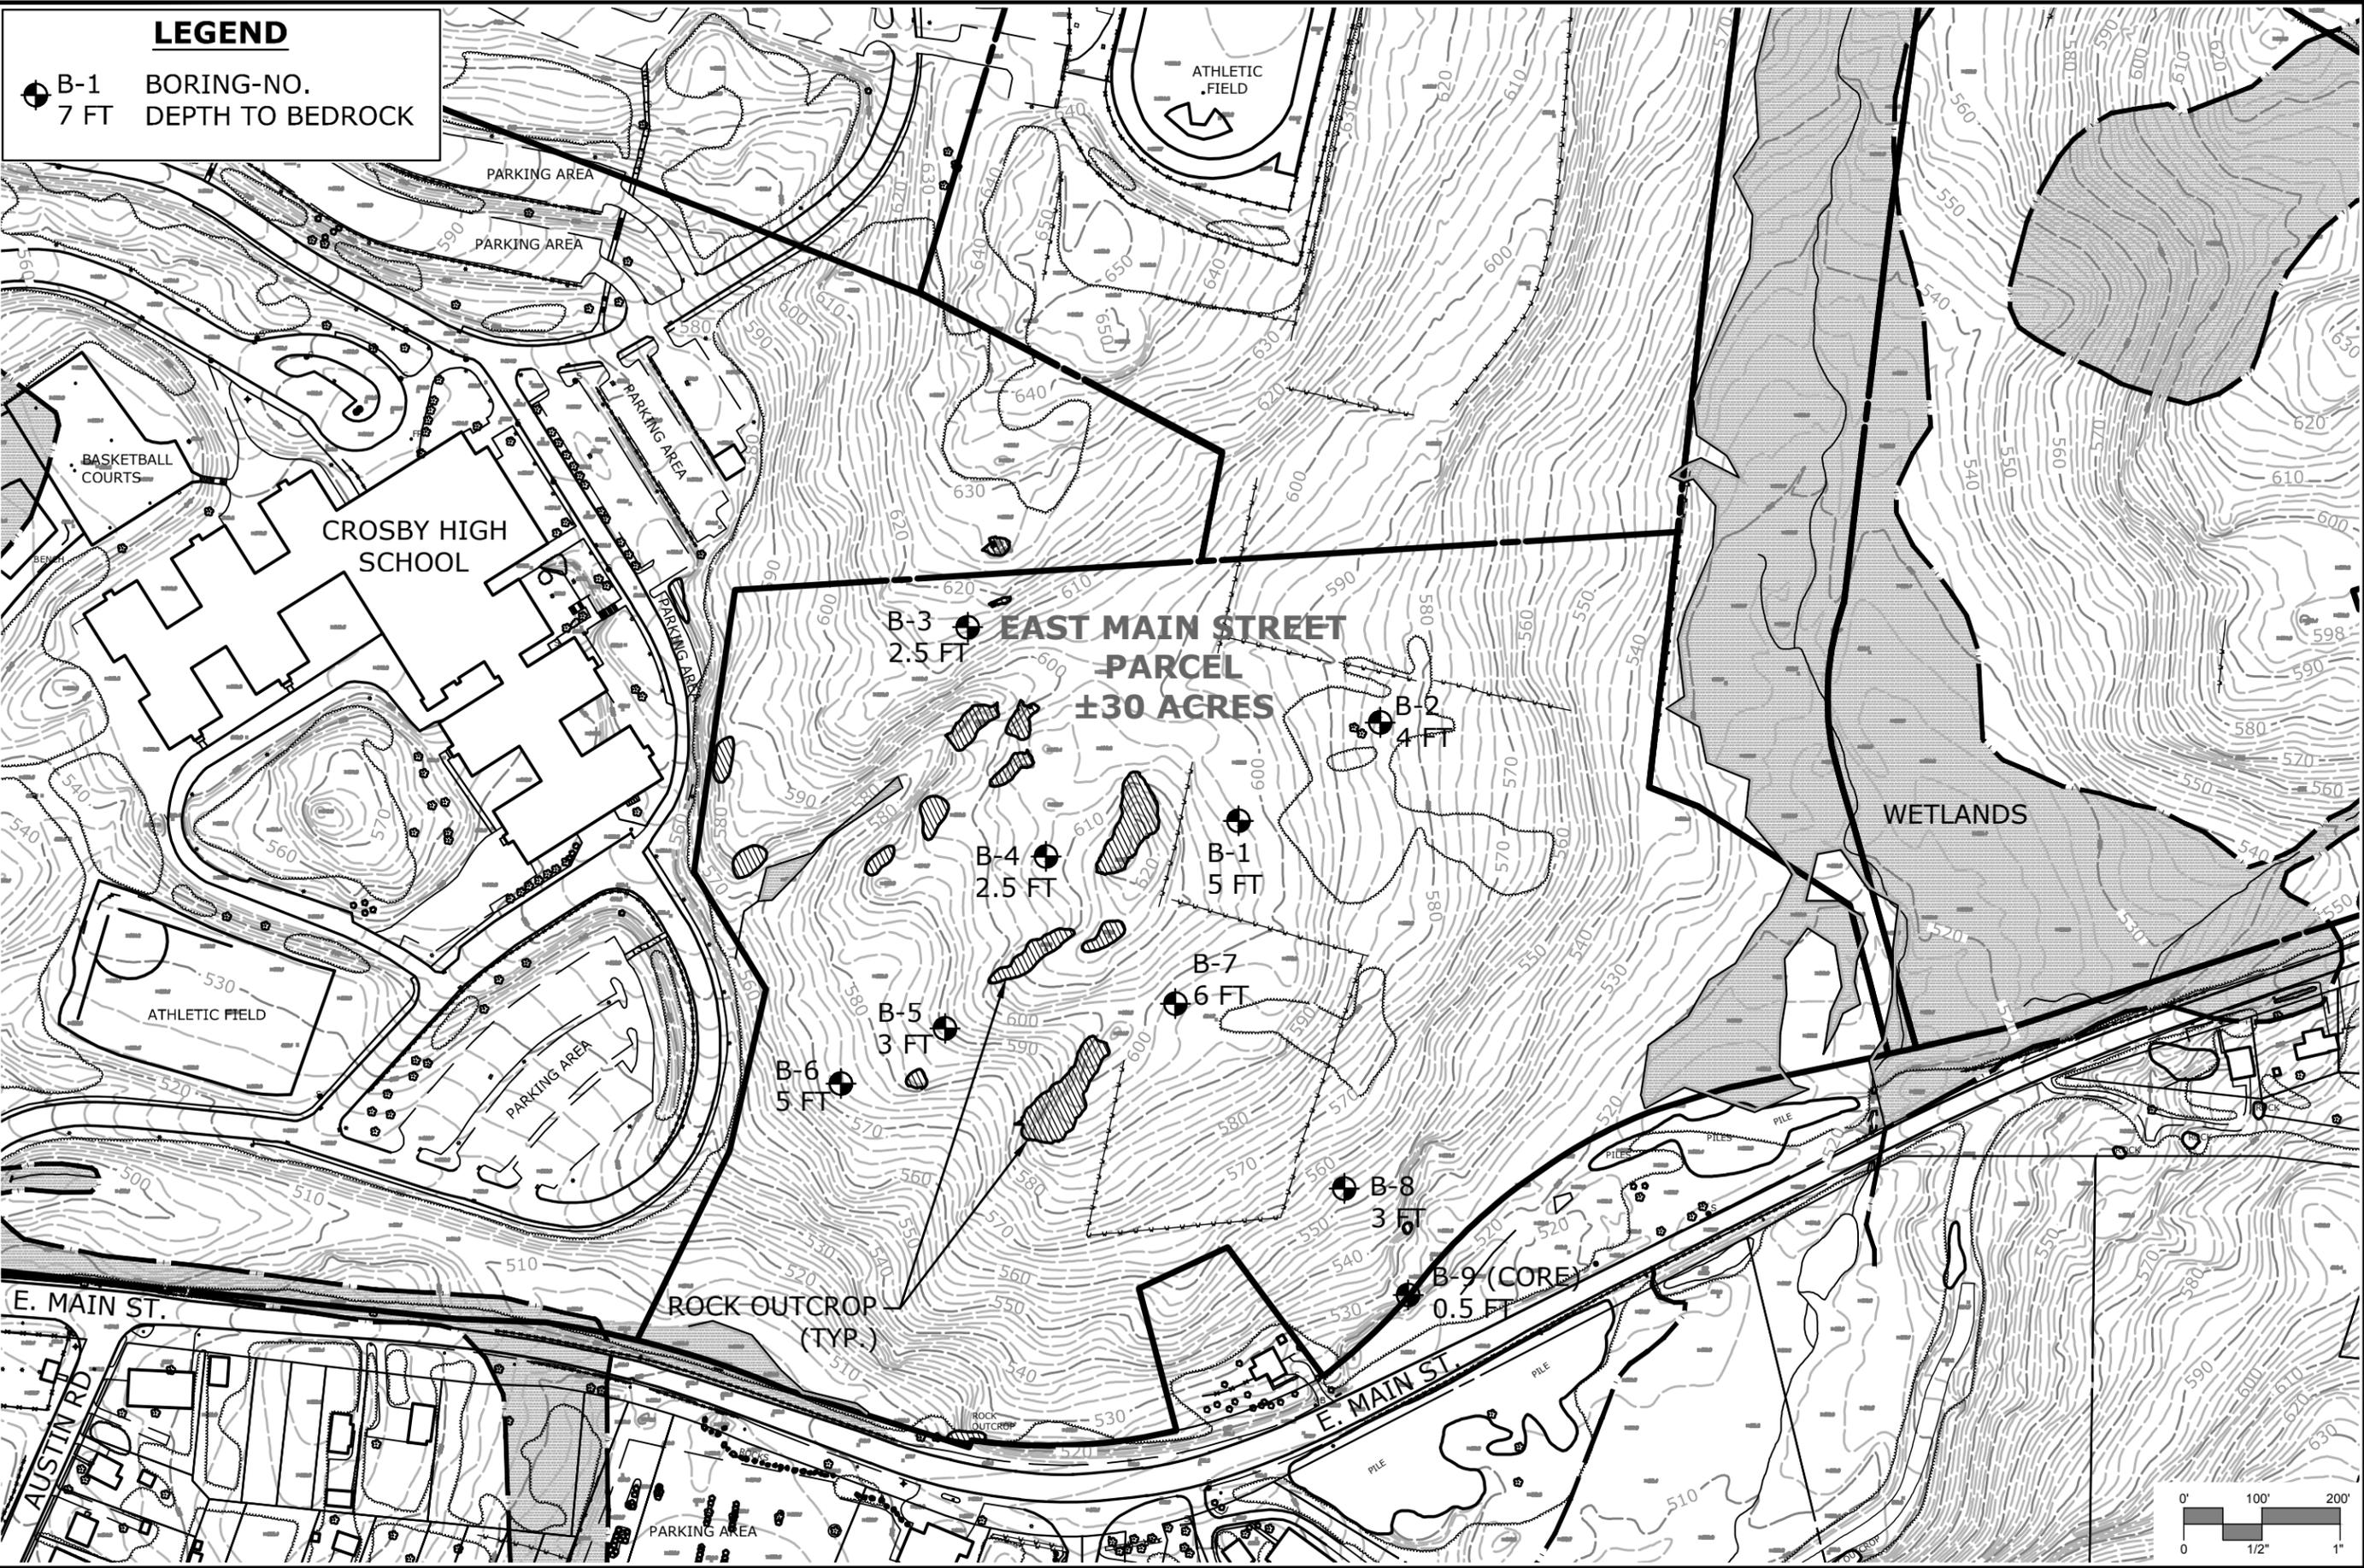
DESIGNED	TEB	CHECKED
SCALE	1"=200'	
DATE	JULY, 2015	
PROJECT NO.	1014-53	
FIGURE NO.	1-1

### EXISTING CONDITIONS AND BORING LOCATIONS

B-1 BORING-NO.  
 7 FT DEPTH TO BEDROCK

**EXISTING CONDITIONS**  
**EAST MAIN STREET**  
 WATERBURY, CONNECTICUT

A total of nine soil borings were completed (B-1 through B-9) from existing grade to the top of the bedrock surface and/or refusal. Sieve analyses were completed on samples collected from B-5 and B-6. A 5-foot bedrock core was collected from test boring B-9. (See Figure 1-1 for Boring Locations, Appendix B for Boring Logs, and Appendix C for Sieve Analysis.)

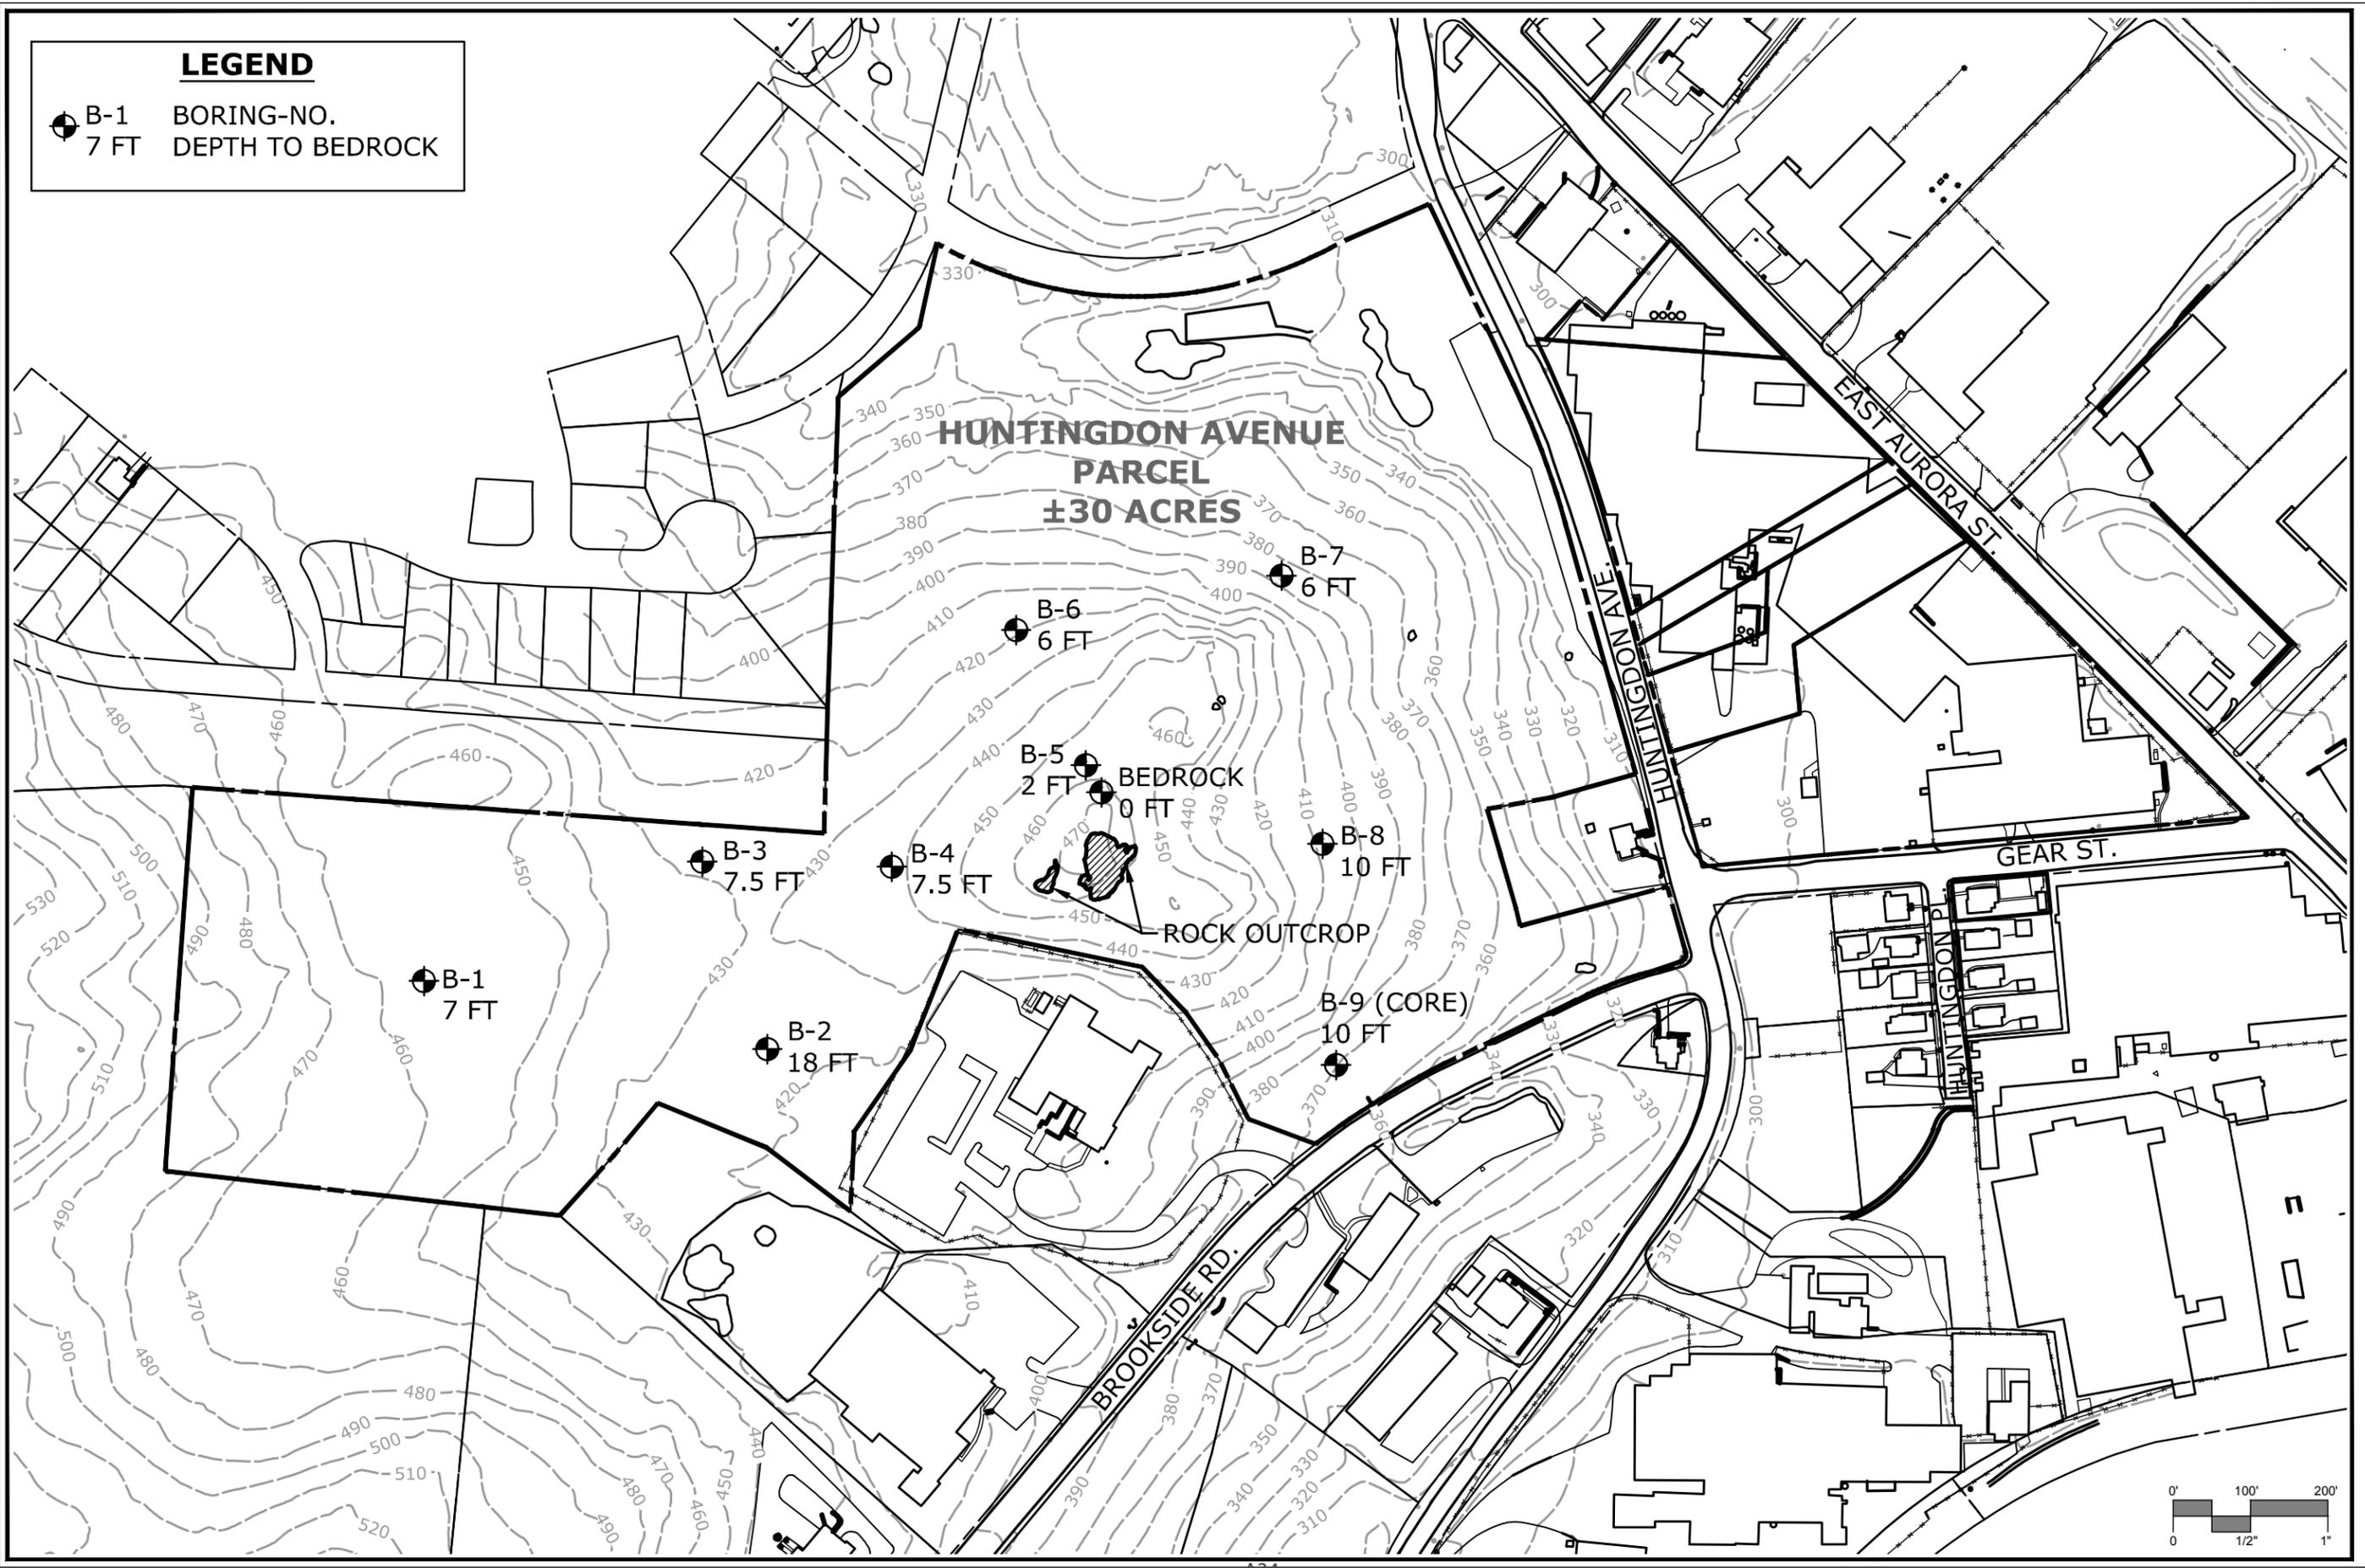
### EXISTING CONDITIONS AND BORING LOCATIONS

● B-1 BORING-NO.  
7 FT DEPTH TO BEDROCK

**EXISTING CONDITIONS**  
 HUNTINGDON AVENUE AND BROOKSIDE ROAD  
 WATERBURY, CONNECTICUT

This parcel is a 30-acre site located in the northern portion of the City. The parcel has approximately 820 feet of frontage along the northern side of Huntingdon Avenue and approximately 550 feet along the eastern side Brookside Road. (See Figure 1-1 for Existing Conditions Map.) Area businesses include, but are not limited to, Tuttle's Auto on Huntingdon Avenue to the southeast and Gem Manufacturing Co., Inc. and Wheeler Clinic on Brookside Road. Transit bus stops are located in the vicinity along Huntingdon Avenue and Brookside Road.

The depth to bedrock ranged from at-grade to 18 feet below grade (ftbg). Test boring B-2 was located in the western valley that extended to a maximum depth observed at the parcel of 18 ftbg. The average depth of the remaining test boring locations was 7 ftbg. In general, the majority of the parcel has a shallow depth to bedrock with outcrops observed at the highest peak in the central portion of the parcel.

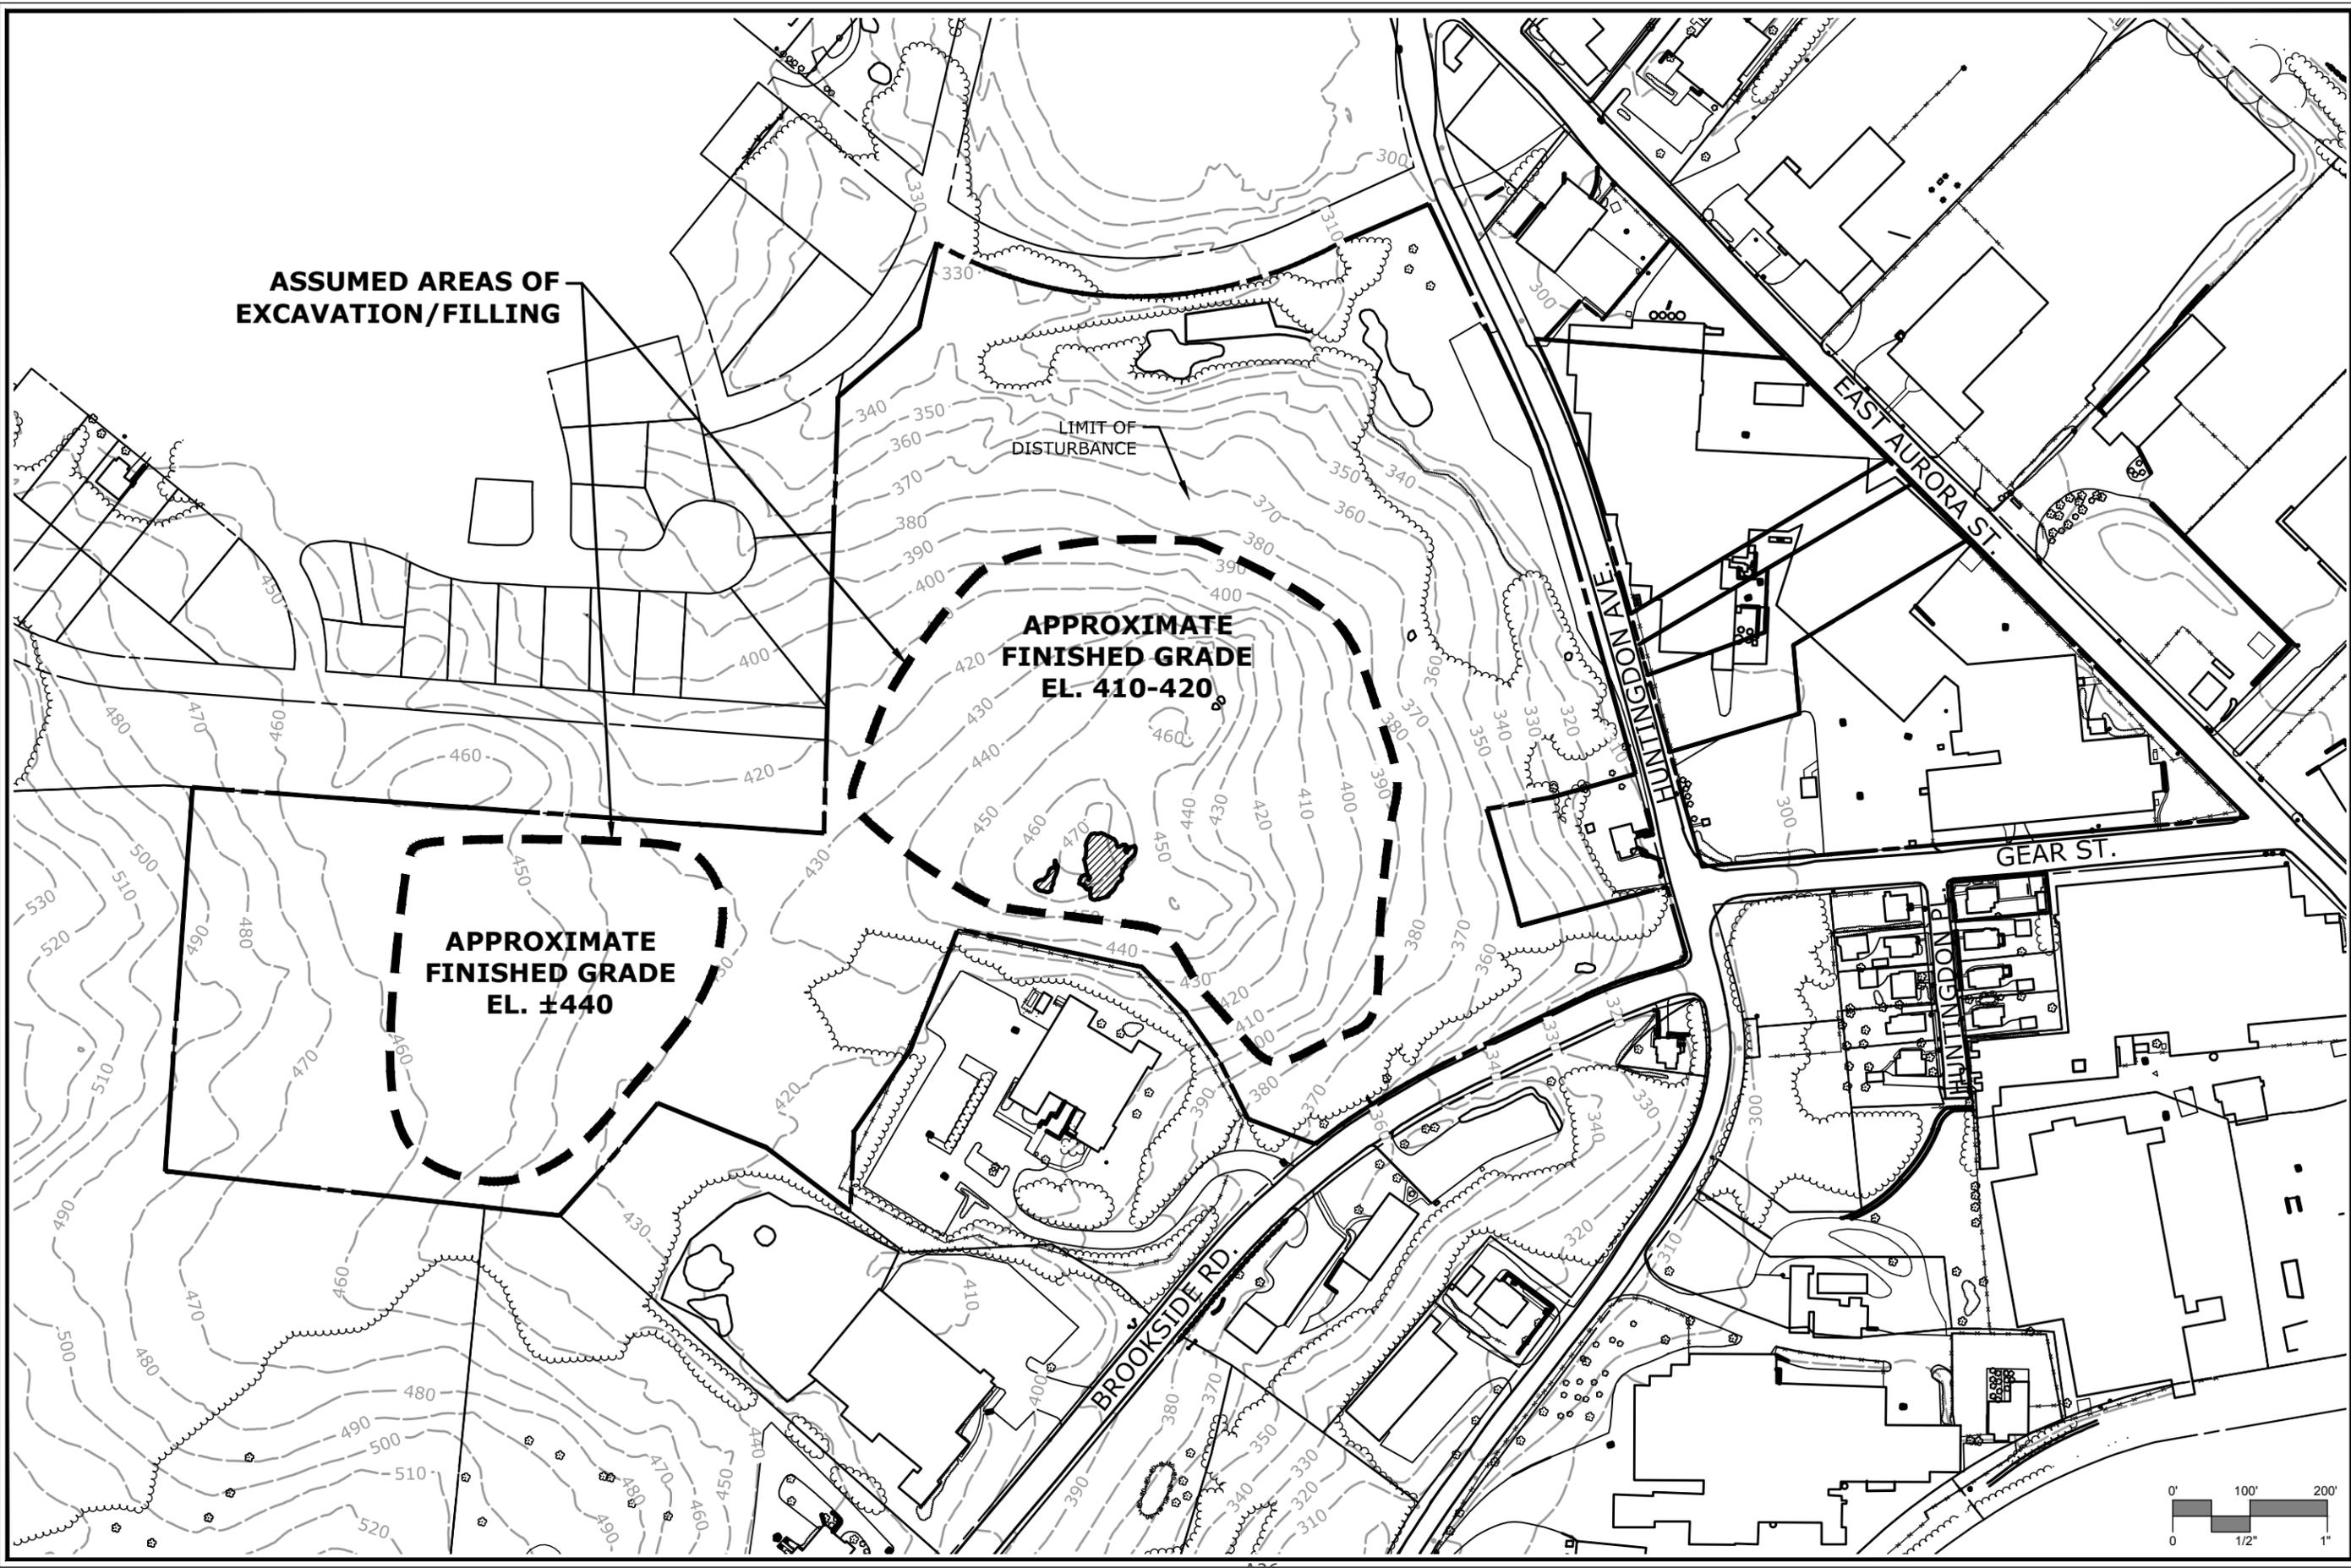
### ASSUMED AREAS OF EXCAVATION/FILLING

Excess rock from the site is expected to consist of a slightly weathered to fresh unit of gneiss or schist. The coarse grained, fractured, weathered, and laminated nature of the bedrock encountered, it is likely not suitable for use as roadway materials, aggregates, or structural fills. Mechanically processed rock materials used for these construction applications must meet minimum standard requirements. Under state Department of Transportation (DOT) and ASTM standards, these requirements include, but may not be limited to, specified tests for the determination of durability, soundness, and resistance to abrasion. While pockets of material potentially suitable to be processed as DOT roadway base material may be encountered, it is anticipated that the predominant use would be for general fill, slope stabilization, or drainage on site or off site.

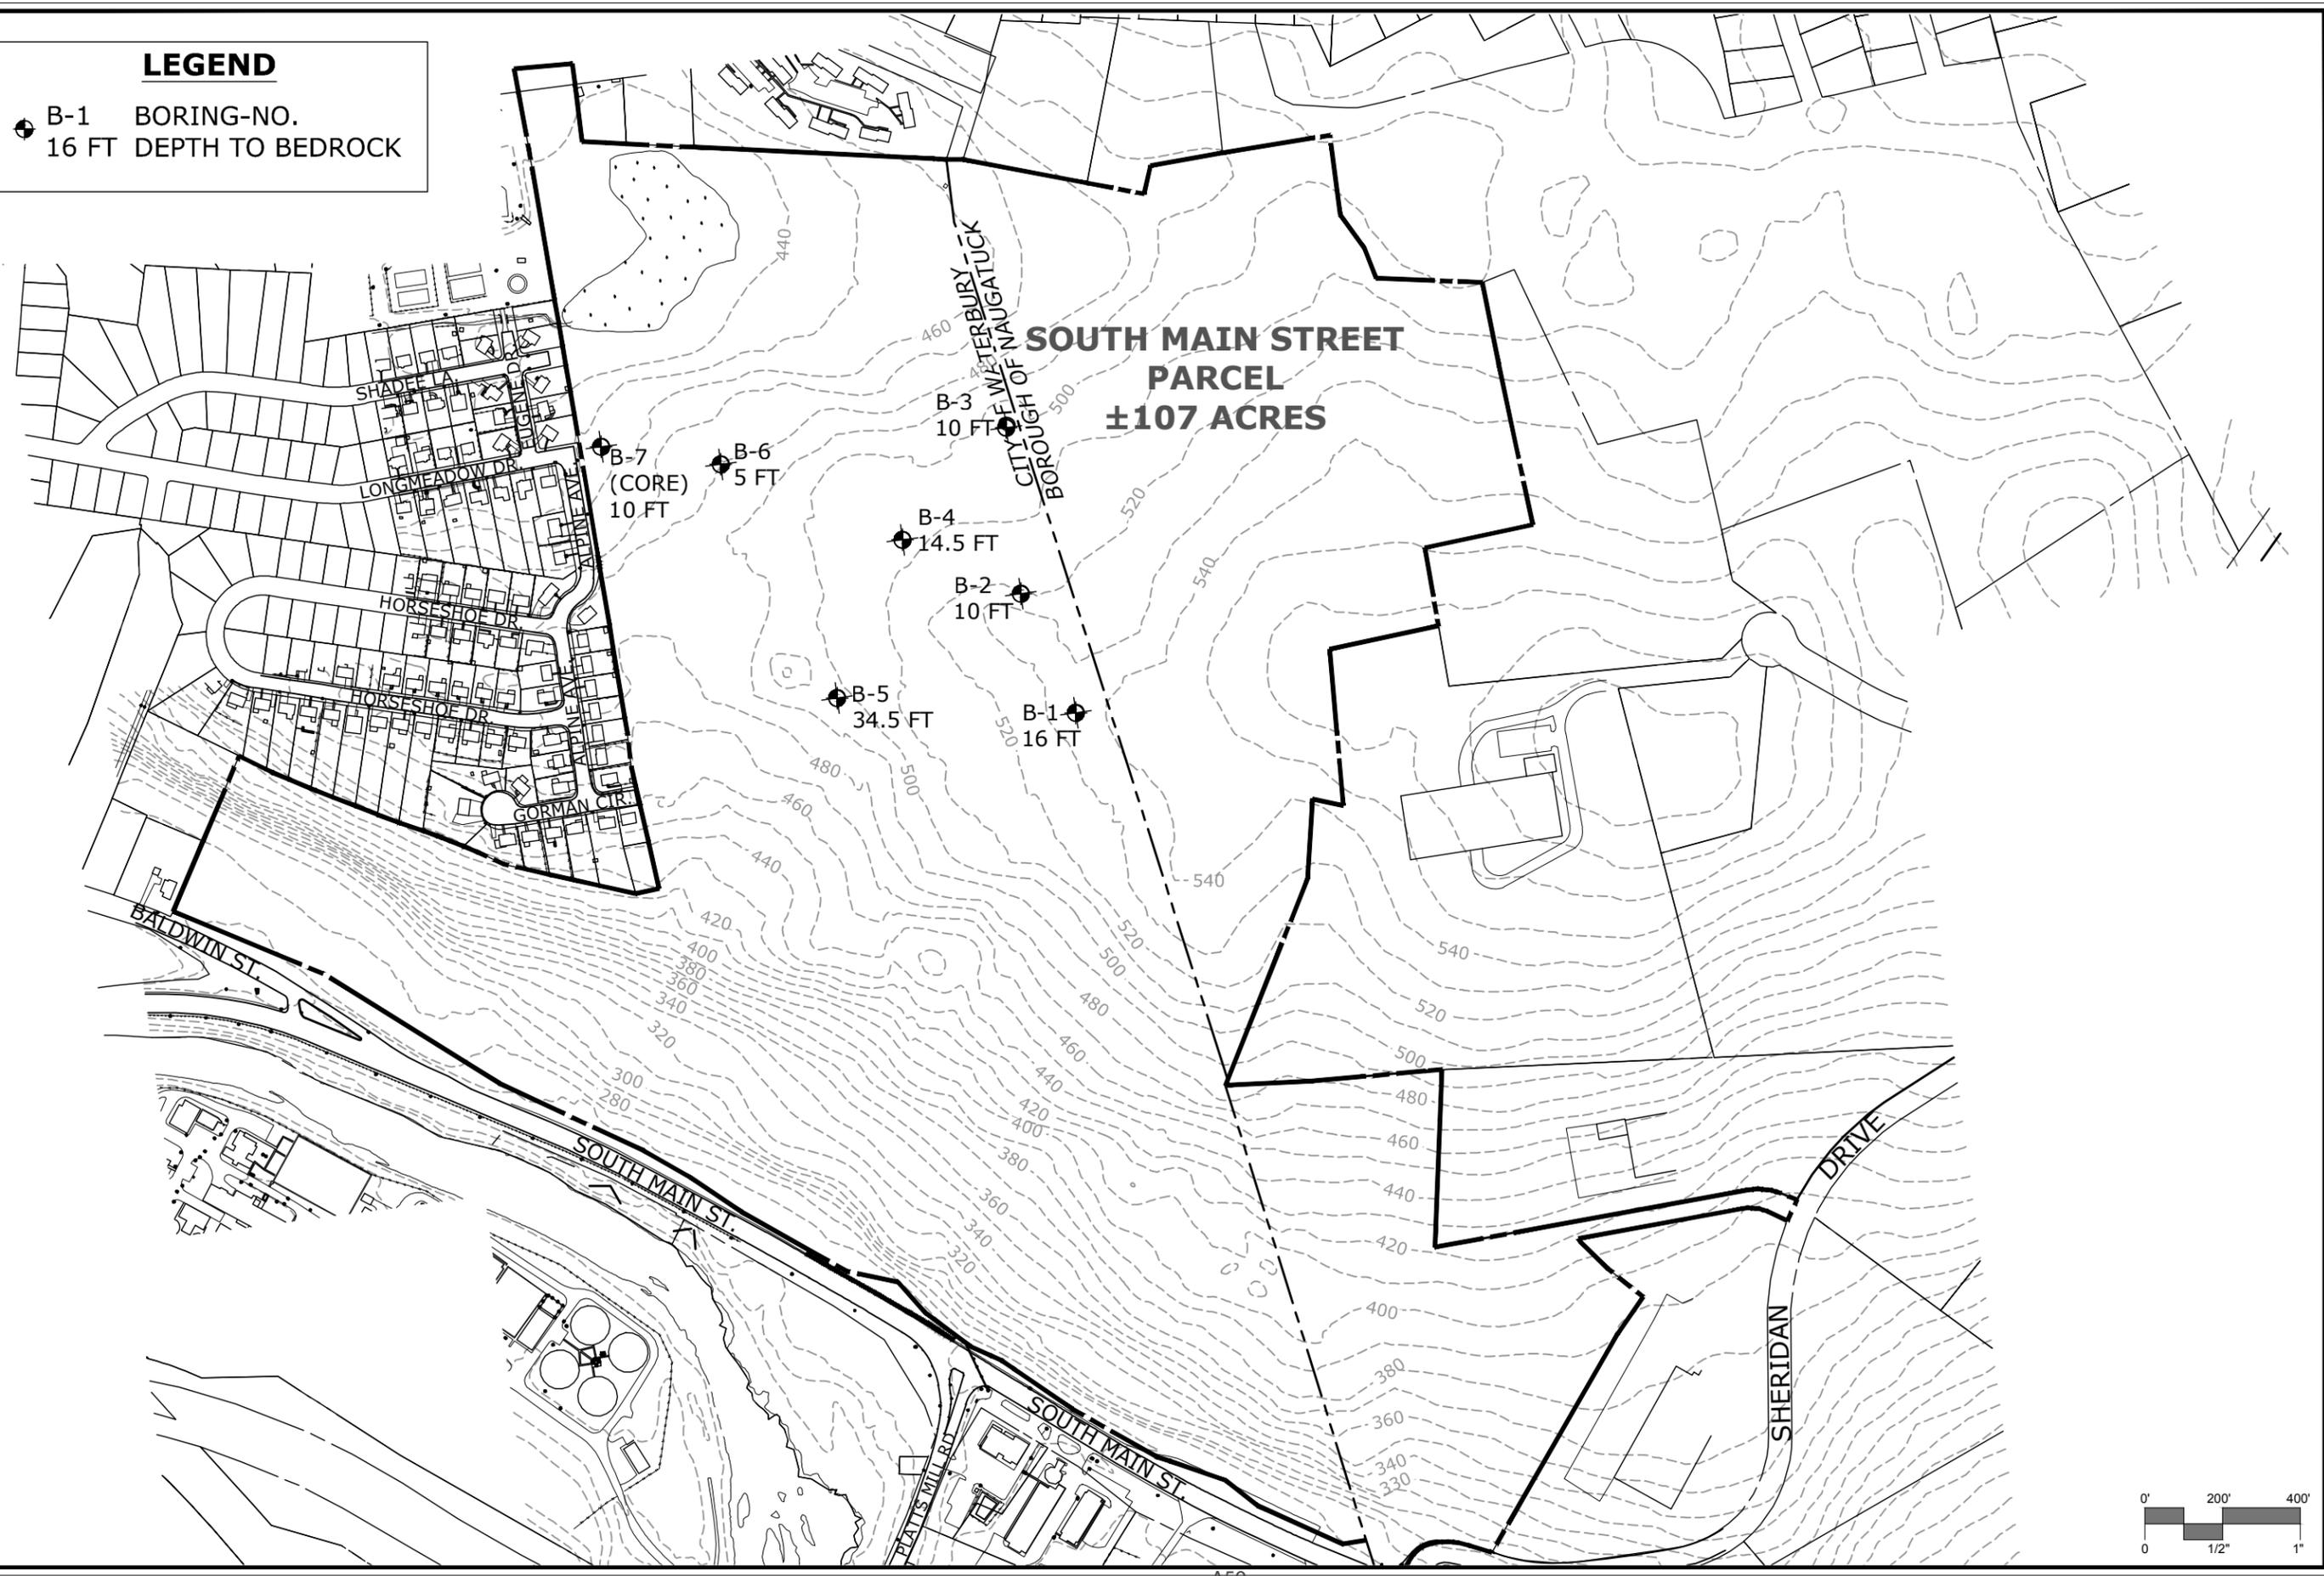
**LEGEND**

● B-1 BORING-NO.  
16 FT DEPTH TO BEDROCK

A total of seven soil borings were completed (B-1 through B-7) including one bedrock core (B-7). Select soil samples from borings B-2 and B-5 were collected for sieve analysis. Borings were completed from grade to top of bedrock and/or refusal. (See Figure 1-1 for Boring Locations, Appendix B for Boring Logs, and Appendix C for Sieve Analysis.)
